FROM HELLENISTIC NEIGHBOURHOOD TO BATH-GYMNASIUM AND  
BEYOND

The archaeology east of the Upper Agora of Sagalassos

BAS BEAUJEAN, JOHAN CLAEYS, DRIES DAEMS, FRANS DOPERÉ, PETER TALLOEN &  
JEROEN POBLOME\*

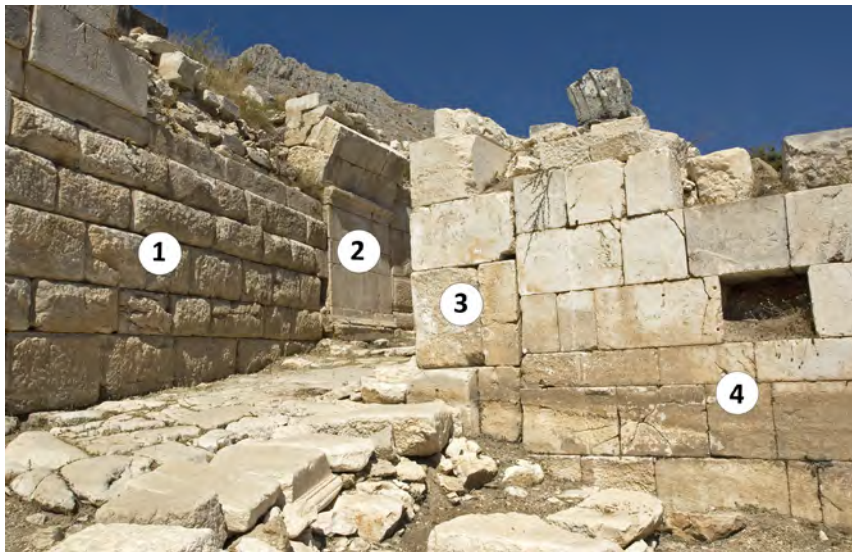
Fig. 3. SW view of the NE corner of the Upper Agora. Indicated are (1) the 150-100 BCE Terrace Building, (2) the 1-50 CE Northeast Gate, (3) the 350-400/450 CE northern wall of the late antique Agora Building, and (4) the western ashlar segment. © Sagalassos Archaeological Research Project.

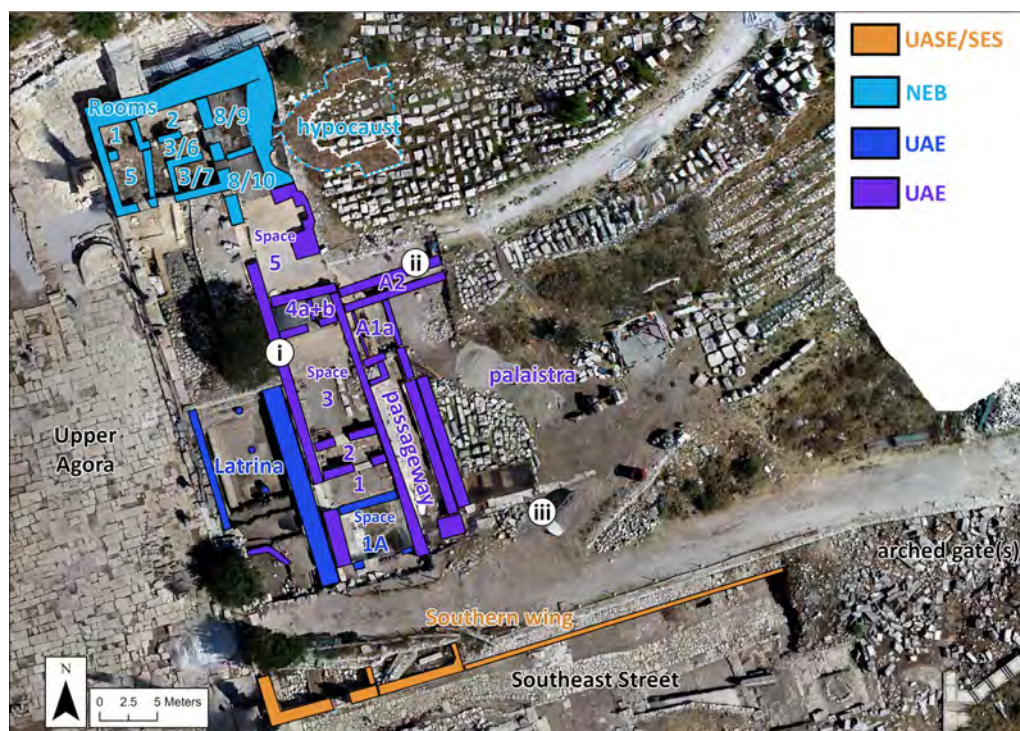
Fig. 4. Map indicating the archaeological subdivision of the area east of the Upper Agora based on excavations: Southeast Street (UASE/SES), Northeast Building (NEB), and Upper Agora East (UAE). © *Sagalassos Archaeological Research Project*.

designated as the Northeast Building (Fig. 4).<sup>8</sup> Between 2001-2004, excavations further exposed the Northeast Building, mostly revealing late antique phases (*c.* 350-650/75 CE).<sup>9</sup> While we no longer follow this dating (*infra*), the aforementioned corner wall was initially argued to belong to 1-25/50 CE based on its neat ashlar masonry construction (Fig. 3).<sup>10</sup> To facilitate conservation programmes on the Upper Agora, the Northeast Building excavations only resumed in 2015-2016<sup>11</sup>, and were concluded in 2021. In 2014-2015, 2017-2019 and 2021, excavations further exposed large parts of the area between the Northeast Building area and the Southeast Street (Fig. 4), which provided information about Hellenistic, Roman Imperial, and Byzantine times.<sup>12</sup> Last, excavations along the Southeast Street in 2014-2015, 2018-2019 and 2021 exposed a continuous wall, which originally belonged to a complex north of the street, and included (a) monumental, inscribed

The interior of the Agora Building – situated west of the (western) passageway and *palaistra* – was also modified. In Space 1A (Fig. 4 and 23), the northernmost part of a room was situated, still delimited in the east by the Hellenistic wall (Fig. 11). The western wall of this room is mostly obstructed by later modifications, but the visible part consisted of mortared rectangular ashlar of varying sizes (Fig. 17). The use of lime-based mortars in ashlar masonry is rare at Sagalassos. In all likelihood, this was done to even out the

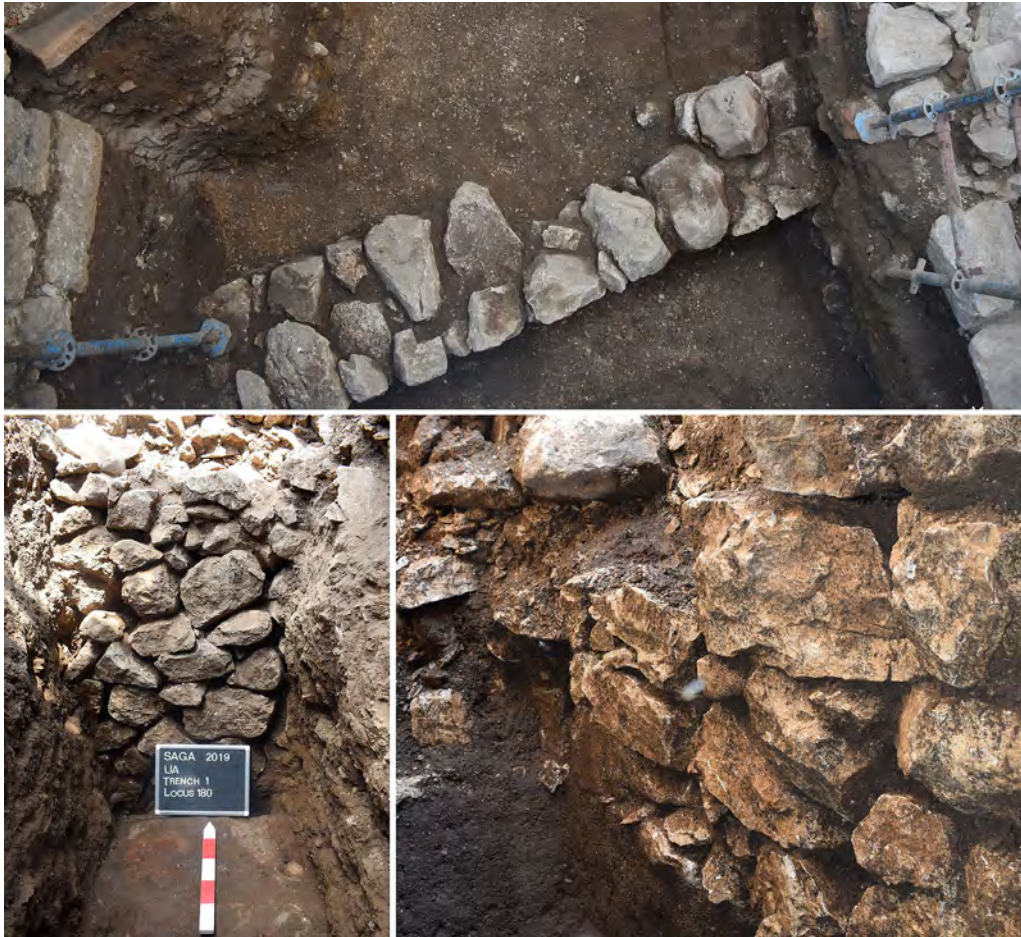
Fig. 5. (above) The 300-150/100 BCE wall in Space 1A. (left) One of the 300-250/200 BCE walls below the Upper Agora. (right) The 300-150/100 BCE western wall.

The largest of these walls was exposed below Space 1A over a length of 5.65 m. It was oriented SW-NE and was 0.6-0.8 m wide (Fig. 5). The presence of later buildings above did not allow for the excavation of its foundations. As the wall's trajectory continued below and was subsequently interrupted by a 200/150-100 BCE ashlar wall (*infra*), we can set a *terminus ante quem* for its construction and use in 200/150-100 BCE. The lowest exposed layer abutting the wall concerned the reworked Gölçük tephra, which suggests that this structure was not erected in a former clay pit. The 200/150-100 BCE *terminus ante quem*, the masonry-based similarities with nearby 300-250/200 BCE buildings, and its stratigraphic positioning, allow us to ascribe this wall to 300-150/100 BCE.

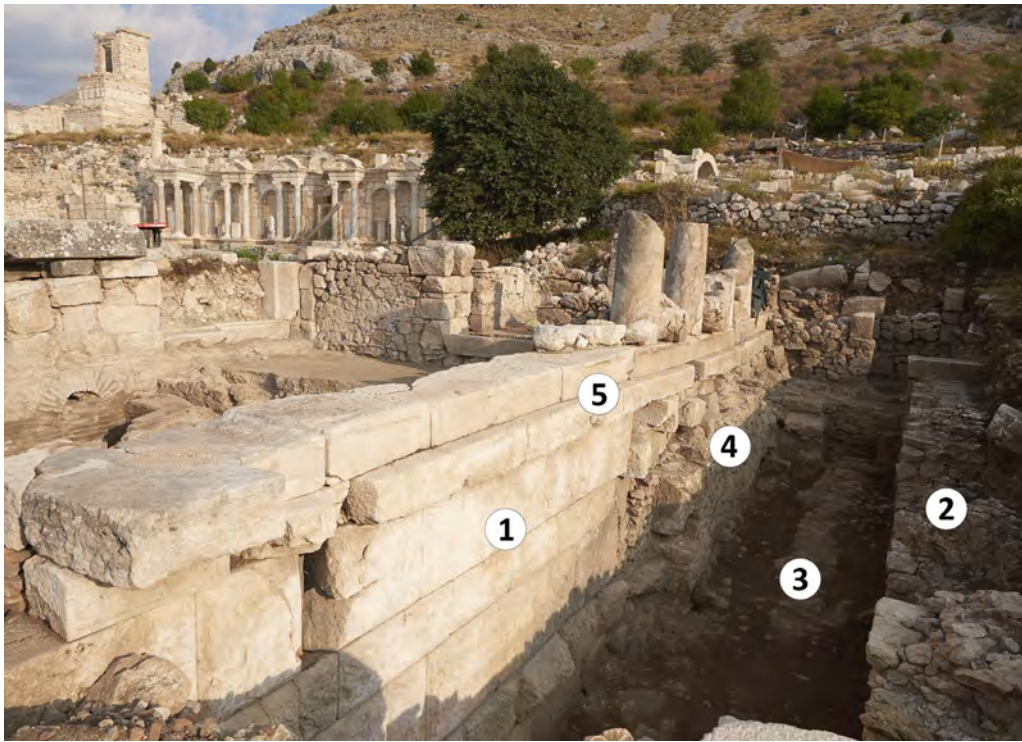
Fig. 8. SE view of the passageway and associated features. Indicated are (1) the eastern wall of the 200/150-100 BCE Agora Building, (2) the 50/25-1 BCE double retaining wall of the *palaistra*, (3) the associated passageway, (4) the 350/400-450 CE continuation of the eastern wall, and (5) the stylobate of the western portico of the *palaistra*.

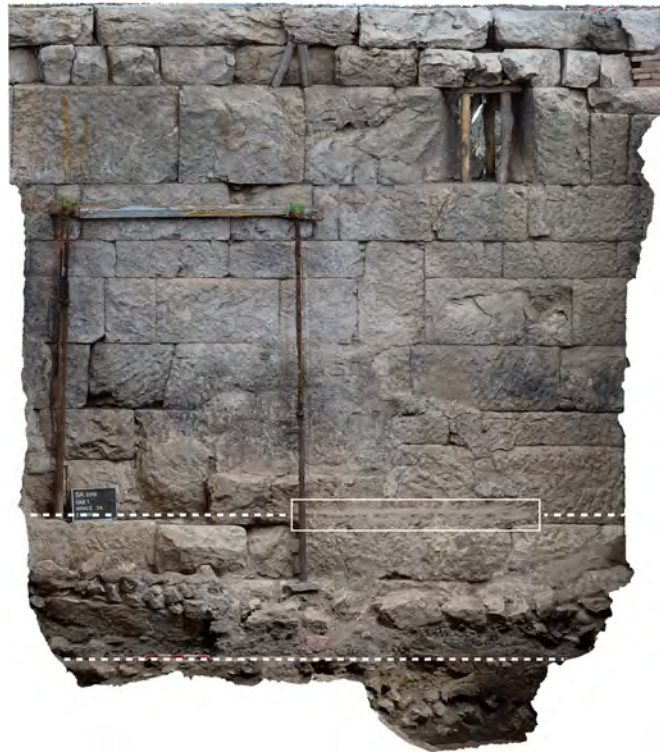
Fig. 11. The eastern profile of Space 1A, indicated are the 50/25-1 BCE beaten earth walking level (below), and the 75-125 CE *opus spicatum* floor (above). This is also the western facing of the eastern wall of the Agora Building. © Sagalassos Archaeological Research Project.

In the eastern aisle we find evidence of an intense fire as well. For example, below the vaulted structure in Space 1A there are burnt spots and soot marks, and the stone has cracked in places (Fig. 38). Similarly, on the eastern wall, cracks are indicative of intense heat, likely associated with a large fire (Fig. 11). As already discussed, various burnt spots

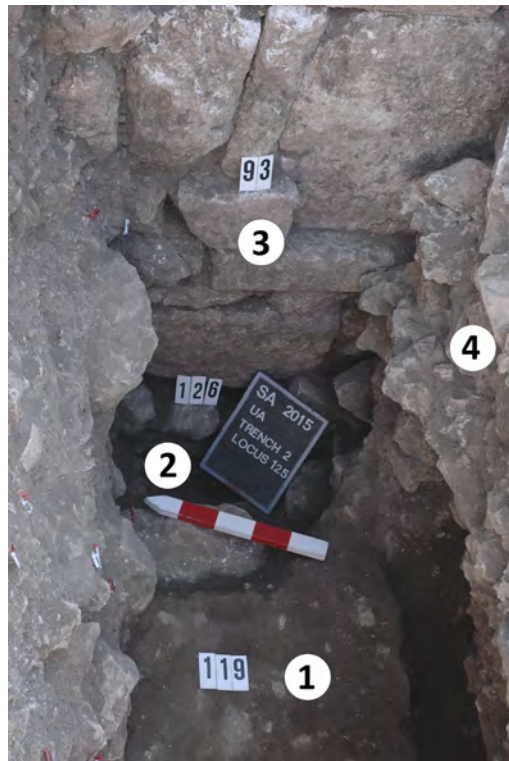
Fig. 12. The western profile in the 2015 control excavation in the SE corner of the Upper Agora. Indicated are (1) the 250-150 BCE walking level, (2) the 200-100 BCE trench and rubble masonry construction, (3) the wall largely consisting of *spolia*, and (4) the thick Roman Imperial stratum composed of mortared rubble.

associated with the foundation trench for the western aisle. To this operation, the already discussed wall segment consisting of reused building blocks can likely be attributed (Fig. 12). This means that the southwestern corner of the Agora-Gymnasium was rearranged during 75-125 CE as well.

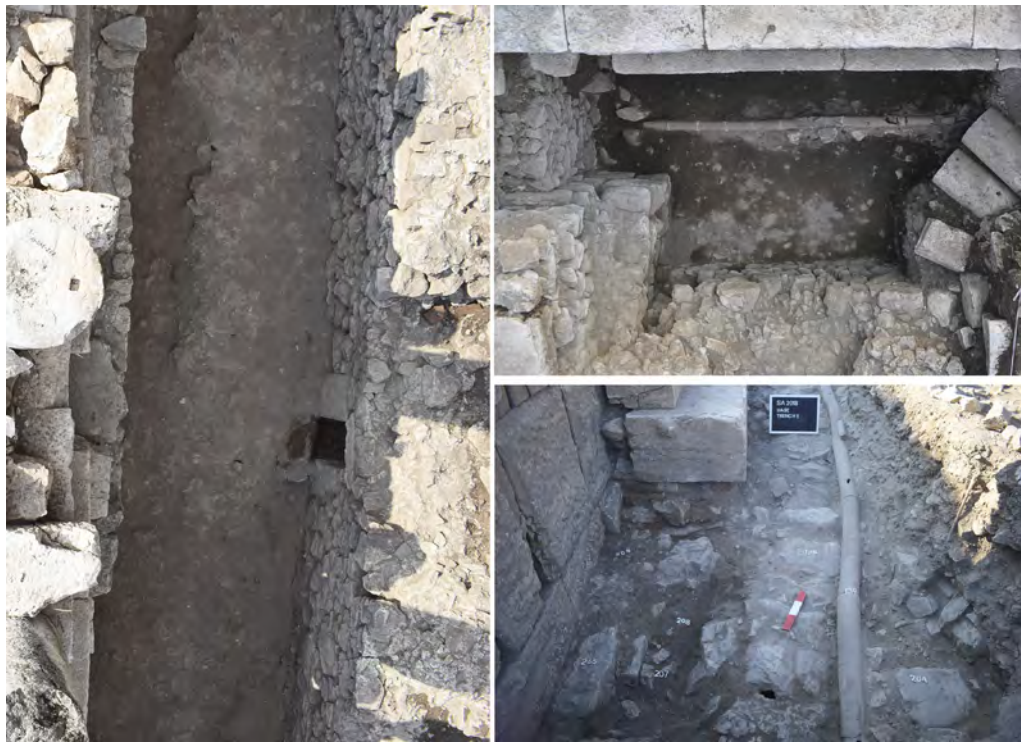
Fig. 15. (left) Bird's eye view of the passageway, including the 1-50 CE NS oriented water channel, and the EW oriented channel connecting to it. (above) View of the southern part of the passageway, including the terracotta pipes installed on top of 550-600 CE levelling deposits. (below) Likely the same 1-50 CE water channel south of Southeast Street, as well as a 550-600 CE terracotta channel constructed on top. © *Sagalassos Archaeological Research Project*.

After the (western) passageway was constructed in 50/25-1 BCE, a N-S oriented water channel (*c.* 13 × 0.7 m) was constructed, and consisted of mortared rubble walls, a brick floor, and limestone cover stones (Fig. 15). The 0.30 m-thick loose gravel- and sand-rich foundation fill of this channel provided a *terminus ante quem* for its construction of 1-50 CE. In the middle of the passageway, another E-W oriented water channel (0.50 × 0.55 m) connects to it via an opening constructed in the double wall. This suggest that this smaller channel was built first. Based on structural similarities, trajectory, and a comparable 1-50 CE date, the continuation of the main water channel (Fig. 15) was exposed immediately south of Southeast Street, descending along the eastern wall of the 50/25-50 CE building(s) in the Makellon area (Fig. 1). As such, the channel was at least 39.4 m long.

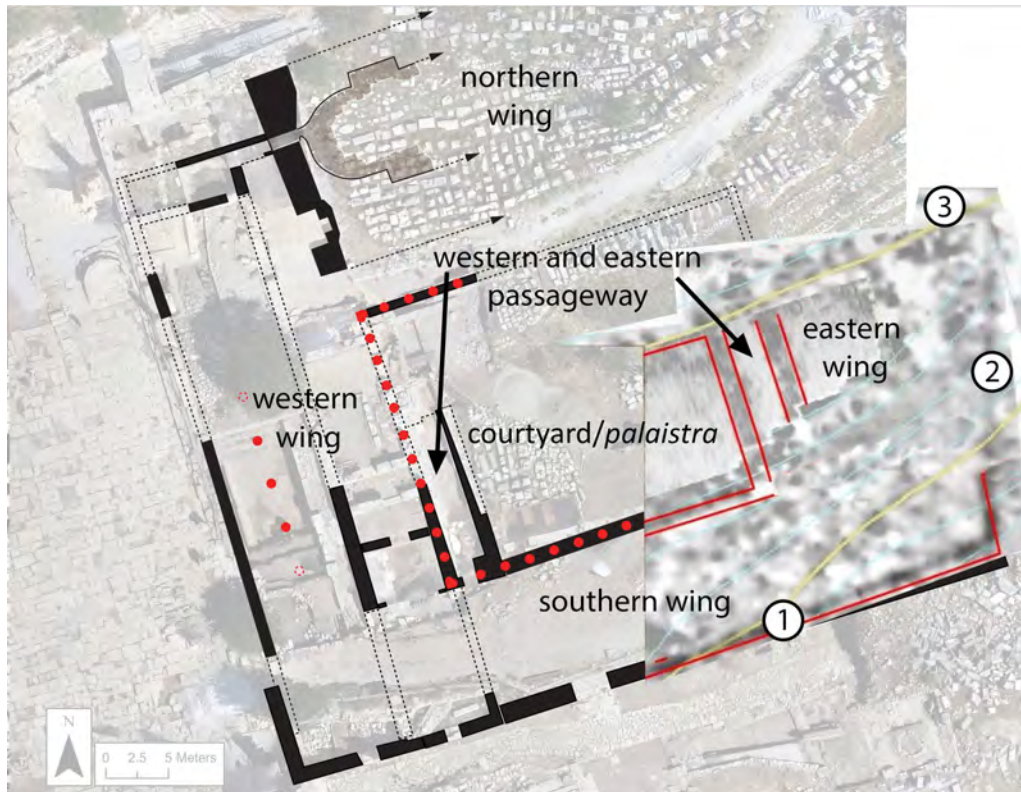
Fig. 16. The geophysical results informing about the extent of the courtyard/palaistra, the eastern passageway, and the eastern wing. The continuation of (1) the southern wall concerns (2) a SW-NE oriented retaining wall which bordered a comparably oriented street to its east. This street eventually hits (3) another crossroads, and delineates the maximum eastern extent of the Agora-Gymnasium.

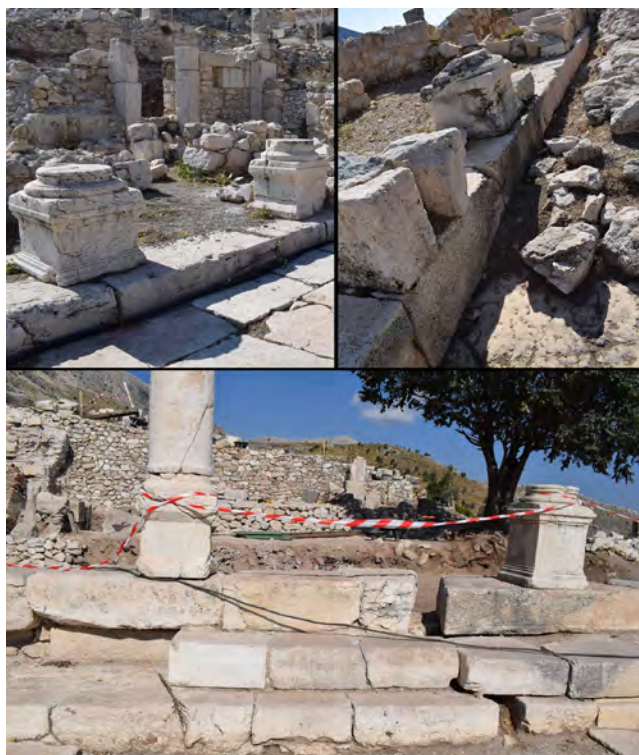
Fig. 21. The in situ stylobate segments of the western (left), southern (right) and eastern (below) portico of the Upper Agora. © *Sagalassos Archaeological Research Project*.

Immediately south of the ashlar wall making up the NE corner of the agora (Fig. 4 and 22), for about 29 m, the lowest course of the border stones and (former) stylobate of the portico is comparable to that of the Western and Southern Portico, including neatly aligned joints (Fig. 21). The partially preserved colonnade on top concerns 350/400–550/650 CE modifications. After this segment, there is a 10 m gap in the stylobate; its blocks were either removed at some point or never present. The final stretch of 6 m

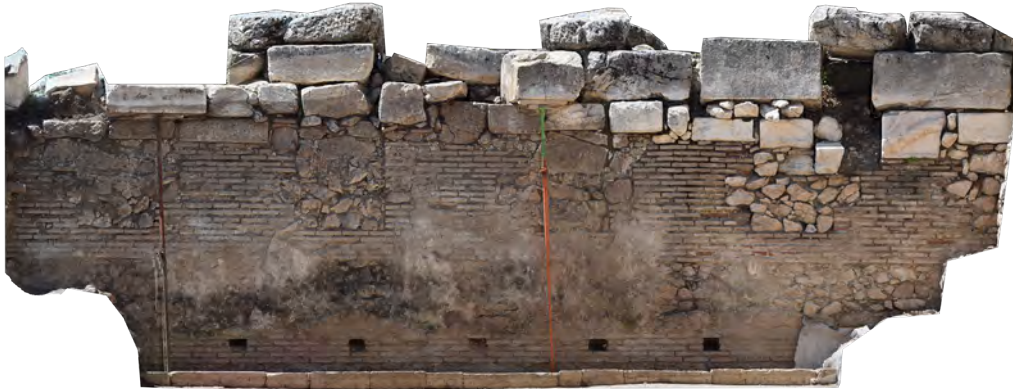
Fig. 24. The western wall of the Agora-Gymnasium's ground floor.  
© *Sagalassos Archaeological Research Project*.

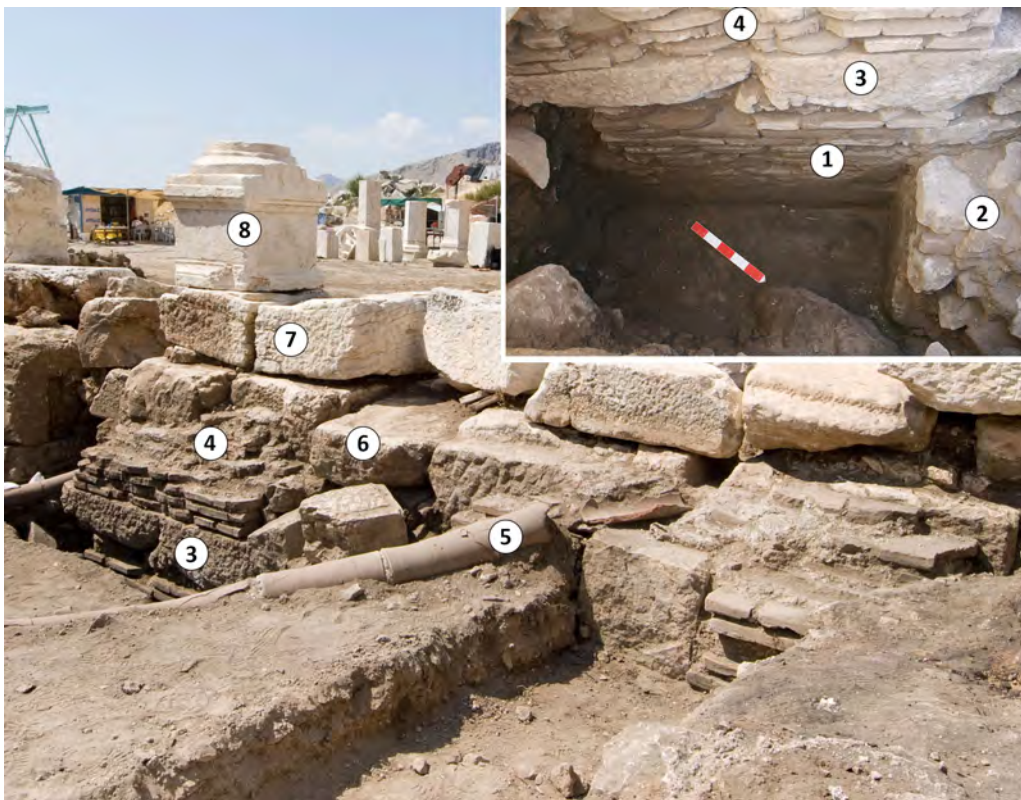
Fig. 25. The control excavation which exposed (1) the northern part of the Agora-Gymnasium's western wall, (2) a 75/125-350/400 CE mortared rubble wall, (3) the easternmost line of agora slabs, (4) a 75/125-650/75 CE brick modification, (5) 550-650/75 CE water infrastructure, (6-8) the 550-650/75 CE eastern portico and its support. © *Sagalassos Archaeological Research Project*.

In the northern part of the western aisle, the upper courses of a mortared rubble wall were exposed, which had been set perpendicular against the 75-125 CE western *opus mixtum* wall (Fig. 25). This mortared rubble wall was abutted by 350-400 CE destruction and levelling deposits, and the associated subdivision thus occurred between 75-125 CE and the 350-400 CE destruction of the Agora-Gymnasium. During the same time range, the marble tile floor was mostly removed for reuse elsewhere. Southwards of the former latrina, articulated concentrations of wall veneering (Fig. 34) were interpreted as part of clearing activities before the western wing was destroyed in 350-400 CE.<sup>67</sup> One way or the other, at least part of the ground floor of the Agora-Gymnasium was being stripped for reusable materials.

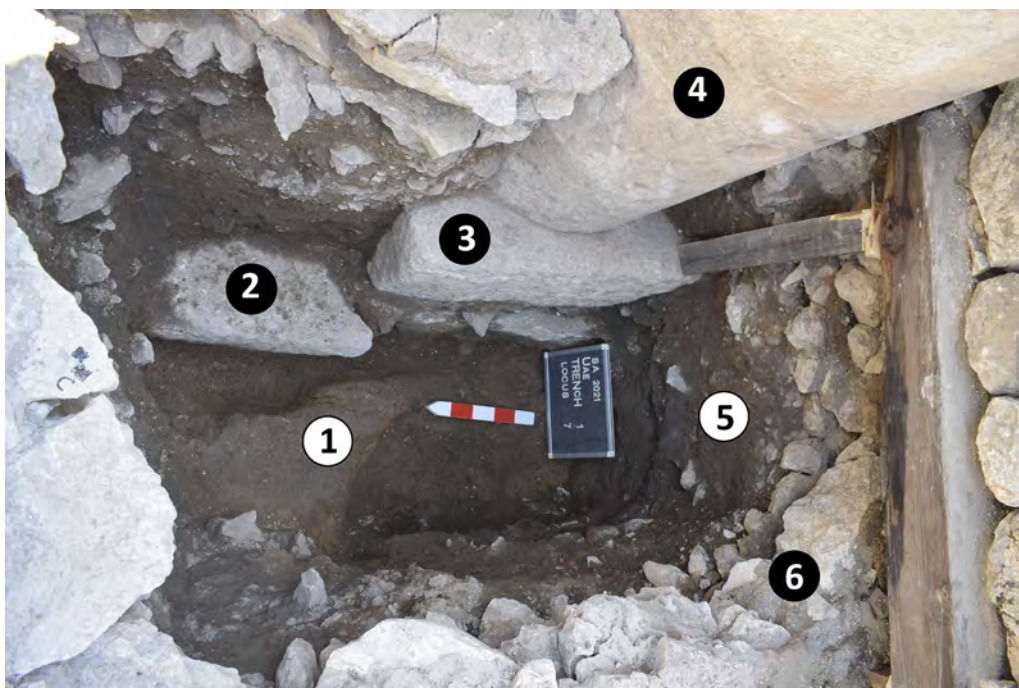
Fig. 27. The control excavation exposing the foundation of the central colonnade of the western aisle. Indicated are the (1) undisturbed parent material, (2) the foundations, (3) the stylobate, (4) the column, (5) the lower backfill of the foundation trench, and (6) the mortared rubble substrate of the mosaic on top. © *Sagalassos Archaeological Research Project*.

stylobate for a series of plain limestone columns (Fig. 27). The stylobate was supported by mortared rubble, and in between the stylobate and columns a lime-based mortar was applied. Subsequently, the foundation trench was backfilled with loam-rich levelling deposits, which based on the amount of faunal remains were brought in from dump sites. The associated ceramics indicate a *terminus post quem* of 75-125 CE. On top of these levelling deposits, a thick layer of mortared rubble was arranged. The few sherds observed in this matrix also belong to 75-125 CE, which provide a *terminus ante quem* for the entire operation. Finally, a mortar setting bed was applied on top of this mortared rubble substrate. Into this setting bed, *tesserae* (1 × 1 cm) were placed, and formed a dichromatic mosaic with meandering, diamond and swastika motifs (Fig. 26). Along the edge, the *tesserae* were bigger (1.5-2 × 1.5-2 cm), forming monochromatic white borders. This mosaic also included figurative panels, including one representing a prancing ibex (Fig. 26). These columns are set approximately 2.5 m from each other, indicating that we are dealing with an araeostyle intercolumniation, and thus a timber support for the first floor. This is confirmed by the documentation of burnt wooden beams in 350-400 CE destruction layers (*infra*), and the absence of evidence for a vault. Three of these columns were completely excavated. Both in terms of diameter (Ø: 0.55-0.66 m), as well as (preserved) height (1.25-1.37 m) there is some variation, and the central one in particular seems to have been smaller. While installed at this location during 75-125 CE, there are additional indications that these columns were in fact reused, and that their production occurred earlier. Stone carving analysis documented traces

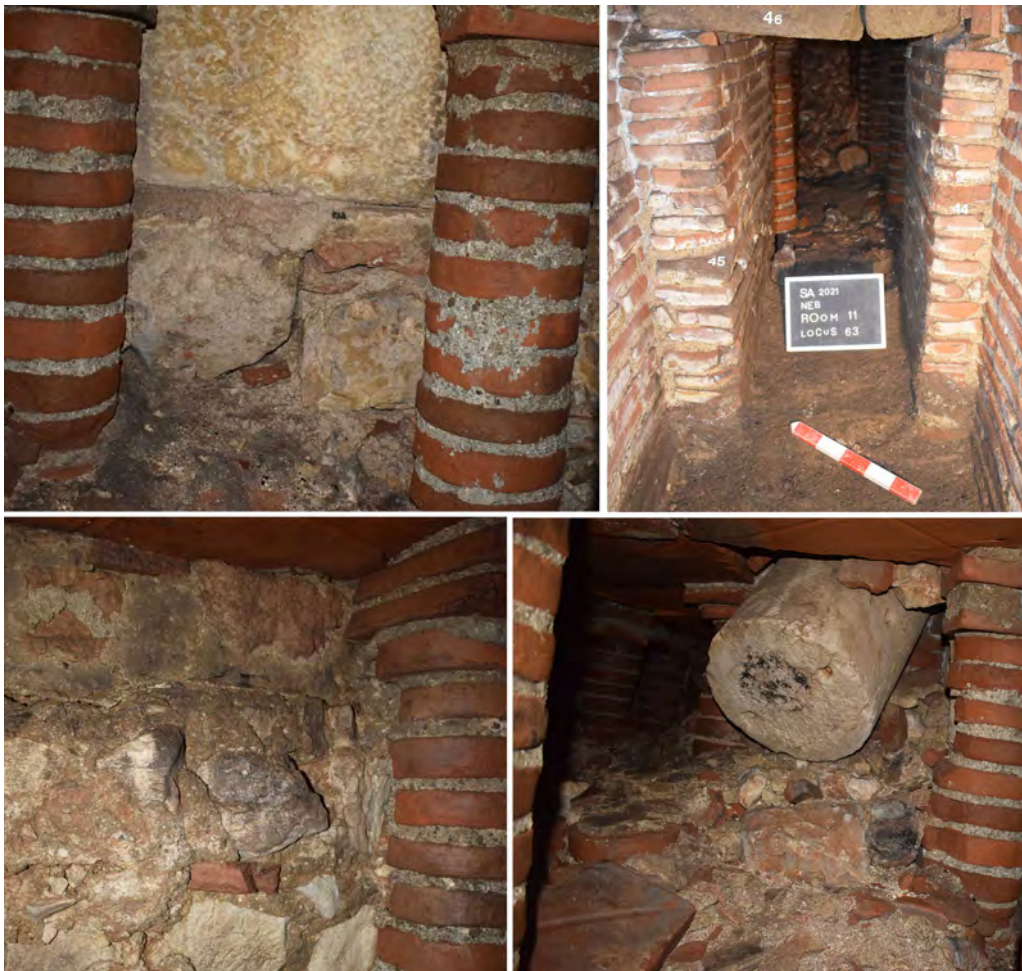
Fig. 29. (upper left) The mortared ashlar wall in the hypocaust of the northern wing. (upper right) The vaulted entrance and service corridor leading to the hypocaust. (lower left) The northern wall of the hypocaust. (lower right) The column which crashed through the ceiling of the hypocaust.

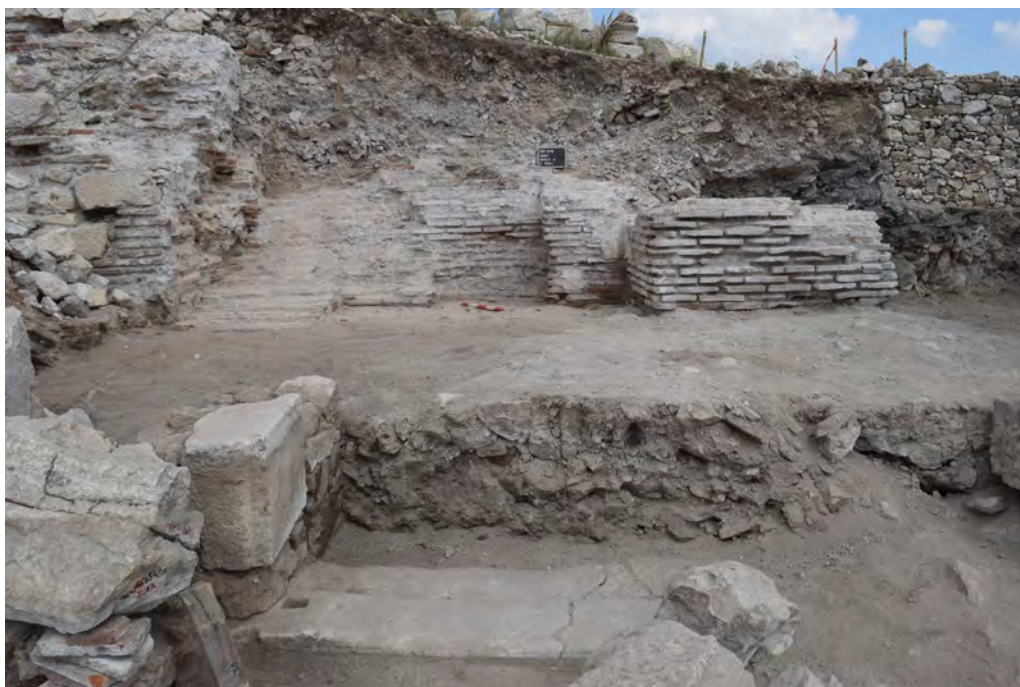
Fig. 30. The southern extremity of the western wall of the northern wing, including the recess.

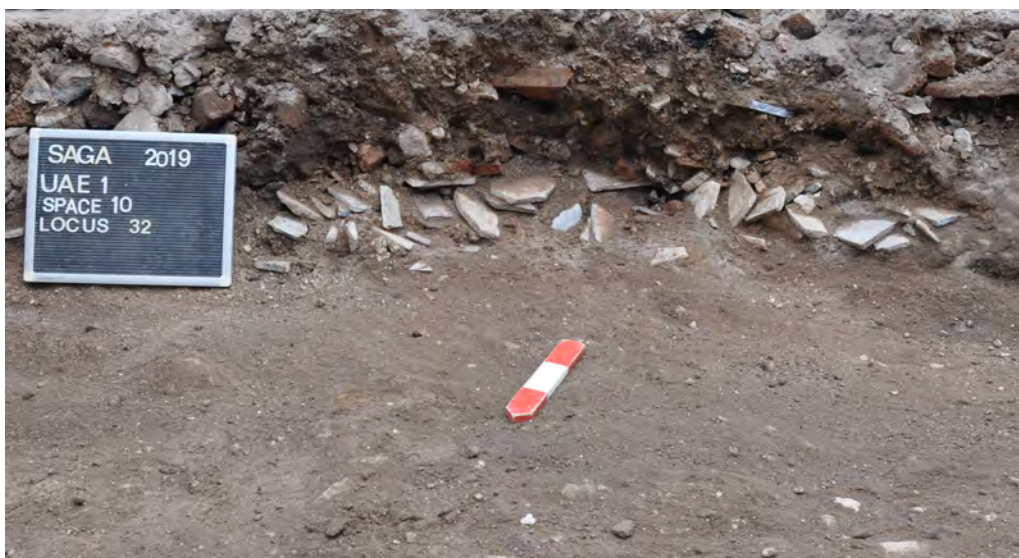
Fig. 34. The concentrations of wall veneering exposed in the latrina area.

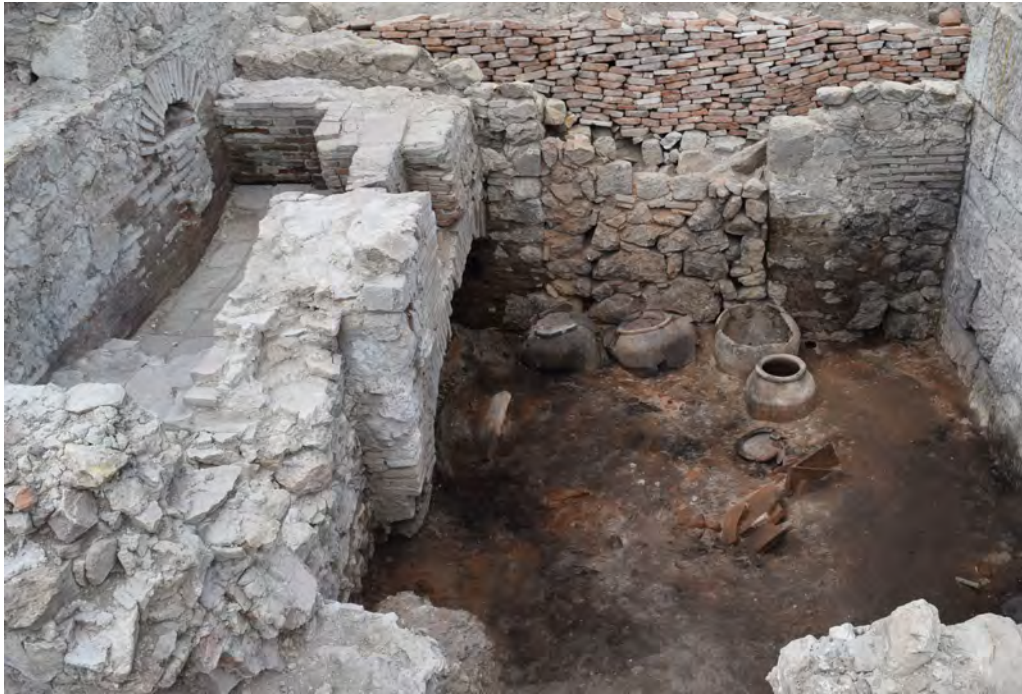
Fig. 35. The 75/125-350/400 CE vaulted superstructure in Space 1A, and several of the 300-350/400 CE storage pots in Space 1A. © *Sagalassos Archaeological Research Project*.

Fifth, as discussed, the 75-125 CE *opus spicatum* floor was only preserved along the eastern wall. This poor state of preservation is a result of it being broken out for the installation of at least seven storage vessels (Fig. 35). Stylistically, the storage pots can be dated to 200-350/400 CE, indicating that this functional change into a storage room occurred during that time frame. Archaeobotanical analyses of the contents of one vessel were suggestive of In addition, smaller ceramic vessels were documented, some stacked on top of each other, others placed within one another like the bowls used for parchment preparation. These vessels range from cooking and storage jars, to dishes and tableware. Quite a few vessels were repurposed, in part as lids for storage pots, while others were modified as their necks were purposefully removed, and replaced with a lid. A unique specimen concerns a ceramic lantern with diamond-shaped incisions (Fig. 36). Furthermore, an eclectic selection of glass items (e.g. *unguentaria*, flask), metal tools (e.g. knife, spoon, scissors), a marble disc

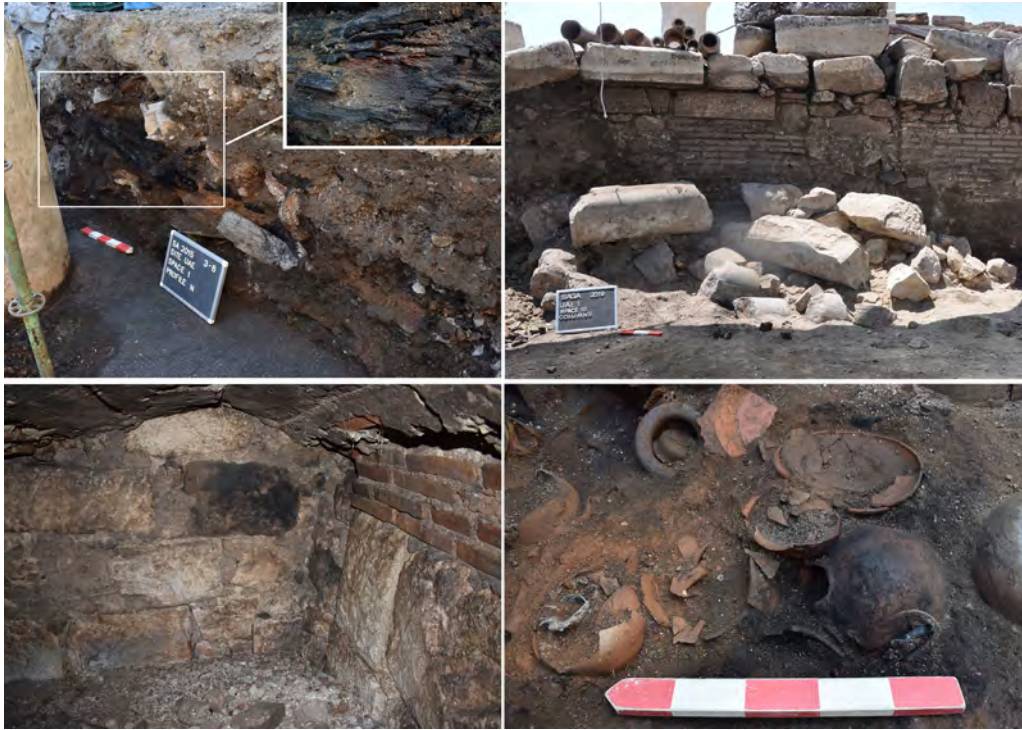
Fig. 38. Evidence of the destruction of the western wing. (upper left) The burnt remains of wooden beams upon the mosaic in the western aisle. (upper right) The collapse of several columns. (lower left) Evidence of a fire below the vaulted space in Space 1A. (lower right) Evidence of a fire amongst the storage pots and finds in Space 1A. © *Sagalassos Archaeological Research Project*.

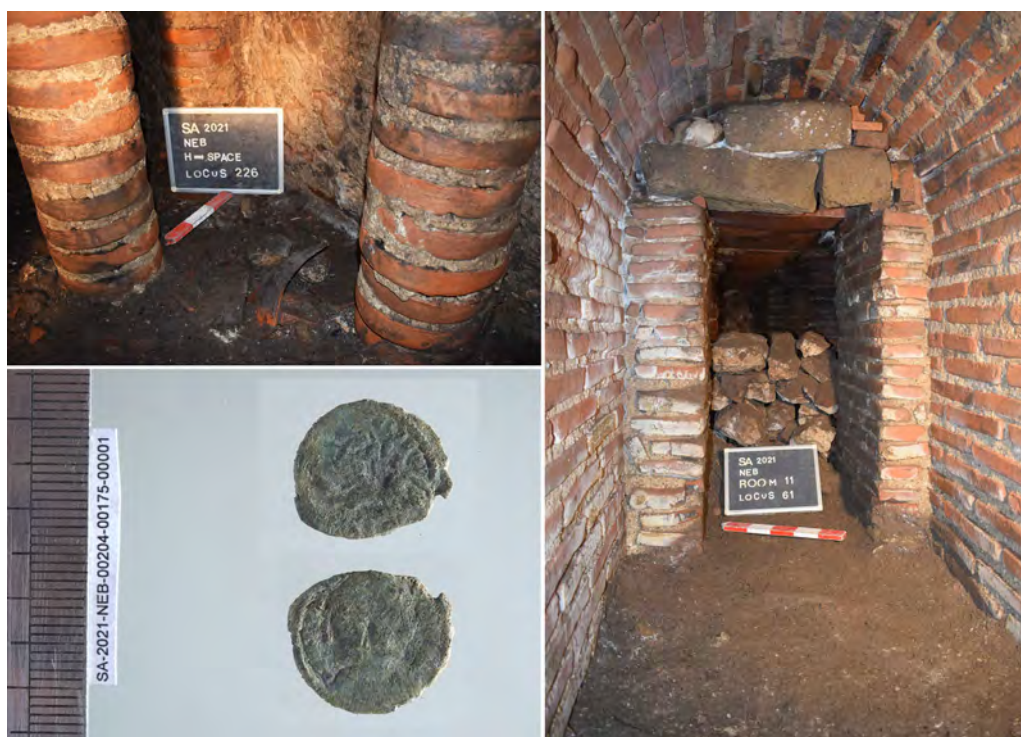
Fig. 39. Evidence of the abandonment of the hypocaust. (upper left) The refuse dumps in the hypocaust. (lower left) The 255-261 CE coin found in this refuse. (right) The dry-laid rubble blockage wall in the service corridor. © *Sagalassos Archaeological Research Project*.

For the northern wing, while there is no evidence for a destructive fire, there is considerable evidence that the hypocaust became inactive. Stratigraphically, the oldest deposit upon the floor of the hypocaust was a thin light brown sand, which was the result of the gradual erosion of the wall. Its minimal extent suggests active maintenance up to 350-400 CE. On top and extending through the hypocaust, was a 0.56-0.72 m thick layer of loose dark grey sand. In it, lots of broken ceramic vessels, faunal remains, and oil lamps were present (Fig. 39). These ceramics were attributed to 300-400 CE. In addition, a few coins were found as well. Most of these were minted during the 3<sup>rd</sup> c. CE, but the two latest could be dated to *c.* 360 CE and 355-361 CE (Fig. 39). Taken together, at some point before or during 355-400 CE, staff stopped maintaining the hypocaust, and refuse started being dumped. During these dumping activities, plain oil lamps were used to lit one's way in the dark. Subsequently, the gradual accumulation of sediment covered these dumps. Finally, the entrance between the service corridor and hypocaust itself was closed off with two dry-laid rubble and tuff rock walls (Fig. 39). The western one was eventually knocked down because of a small collapse from above. The corridor itself was not backfilled, and its entrance closed off by another dry-laid tuff

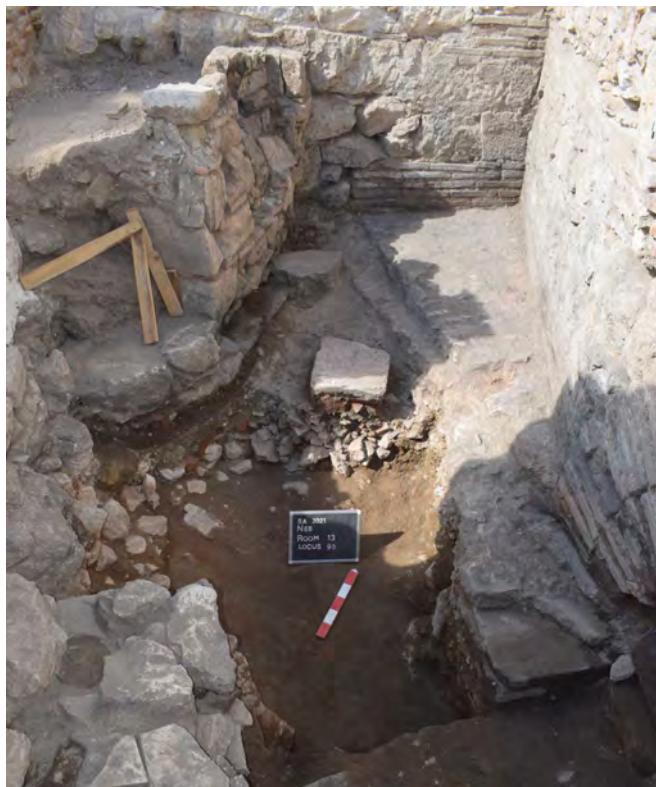
Fig. 40. Southern view of Room 13. In the profile the 350-400 CE backfill of building debris is visible.  
© Sagalassos Archaeological Research Project.

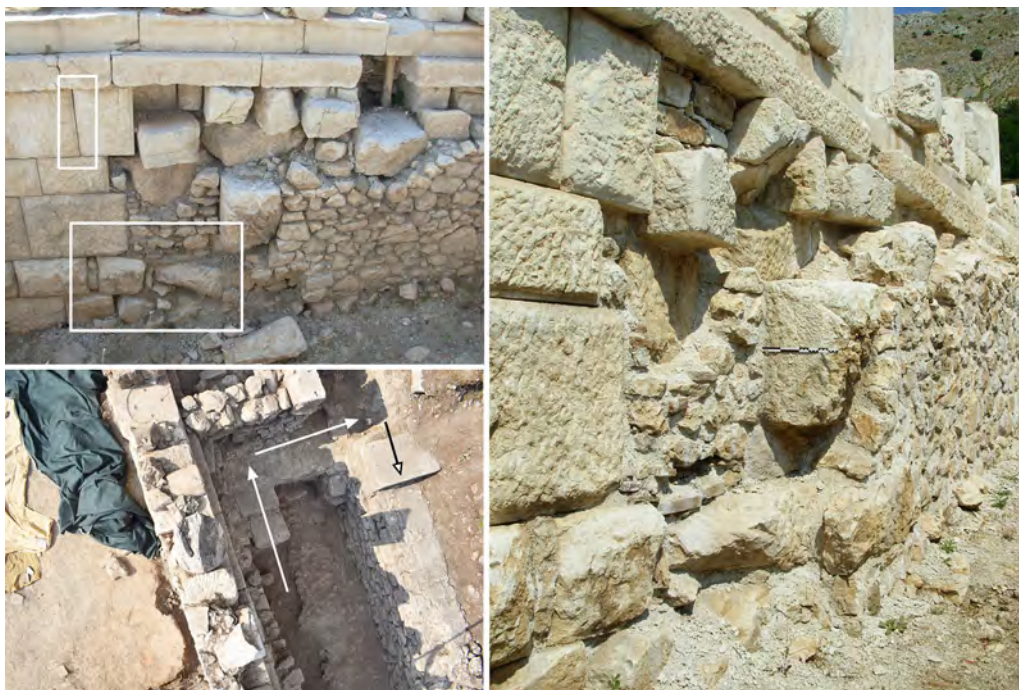
Fig. 42. (upper left) Eastern view of the location where a makeshift extension was placed against the Hellenistic wall. Indicated are the widening of the joints and eastwards protruding blocks indicative of the collapse of the original continuation or extension of the wall. (right) Southeastern view of the same situation, clearly displaying the mortared rubble support wall. (lower left) Top down view of the northern extremity of the extension, including the stairway.

pavement of the former *palaistra* (Fig. 42). This suggests that the courtyard remained in use, though no longer as part of gymnasium-related activities. To facilitate its construction, part of the (vaulted) platform likely spanning the passageway had to be removed as well. The fact that only 550-650/700 CE material was found on top of the 50/25-1 BCE levelling deposits, indeed suggests regular cleaning of the courtyard. We have already discussed the positioning of the western portico on top of the eastern wall of the western wing. As the latter's northern part was likely rebuilt in 350-400 CE, this portico was most likely temporarily removed, including its stereo- and stylobate. This is also suggested by the fact that the four *in situ* circular columns and one angular variant display different stone dressings, which were already in vogue during 50/25 BCE-50 CE. This suggests that we are not dealing with the original arrangement of the colonnade.

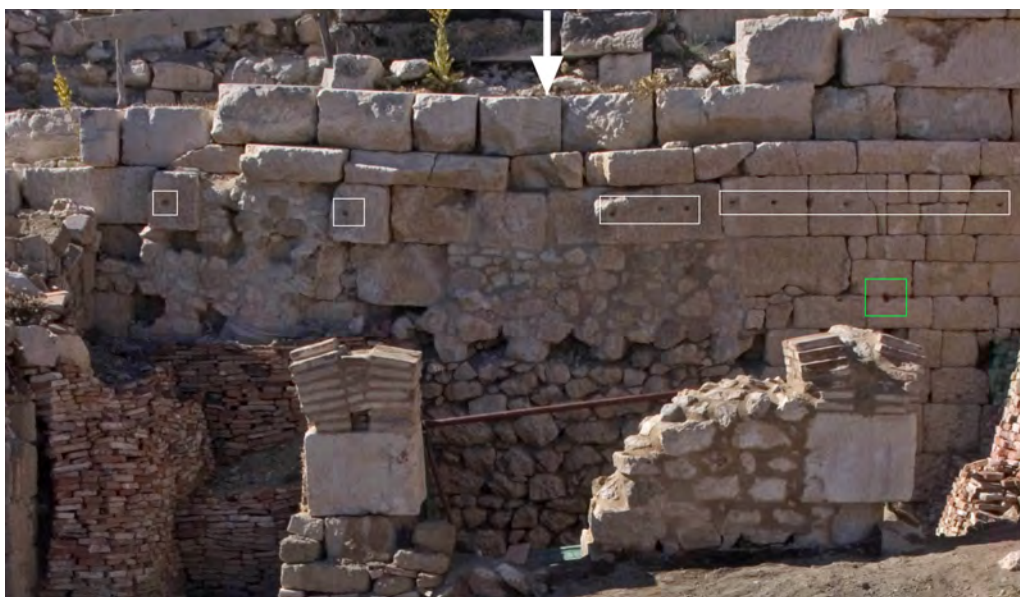
Fig. 44. Southern view of the western segment of the northern wall. Indicated are the area where the wall sags (arrow), the continuous line of clamp holes (white rectangles), and the clamp carved in between two blocks (green rectangle). © *Sagalassos Archaeological Research Project*.

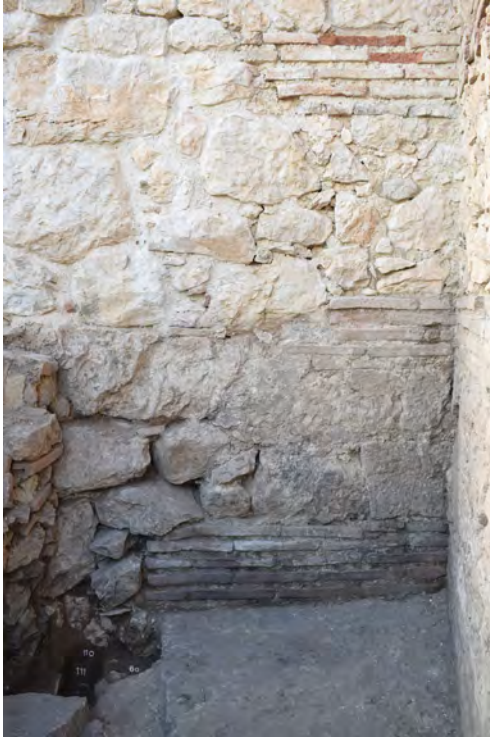
Fig. 45. Southern view of the eastern segment's lower part of the northern wall.  
© *Sagalassos Archaeological Research Project*.

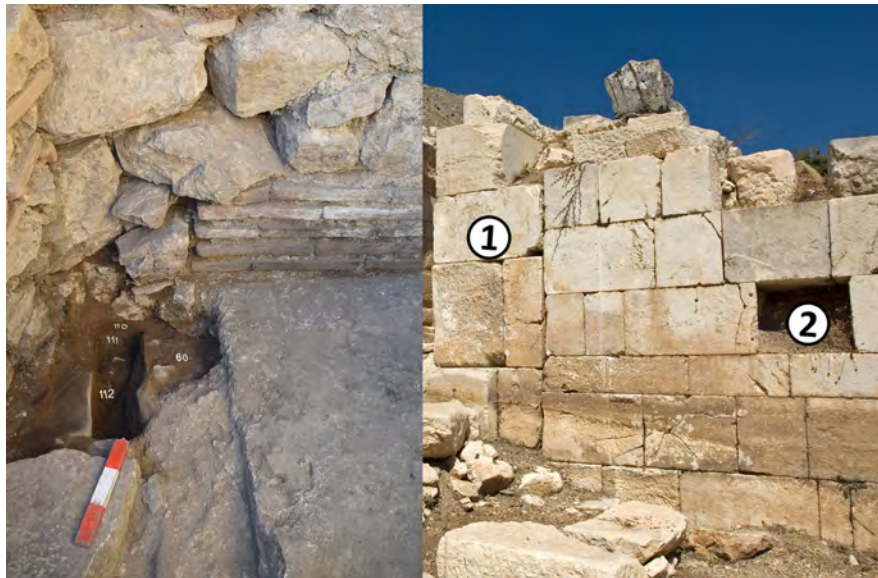
Fig. 46. (left) The profile where the easternmost part of the northern wall's inner face was placed on the WE oriented segment of the 75-125 CE wall. (right) The north-western corner of the late antique Agora Building, where (1) the double northern wall and (2) northwestern wall connect. © *Sagalassos Archaeological Research Project*.

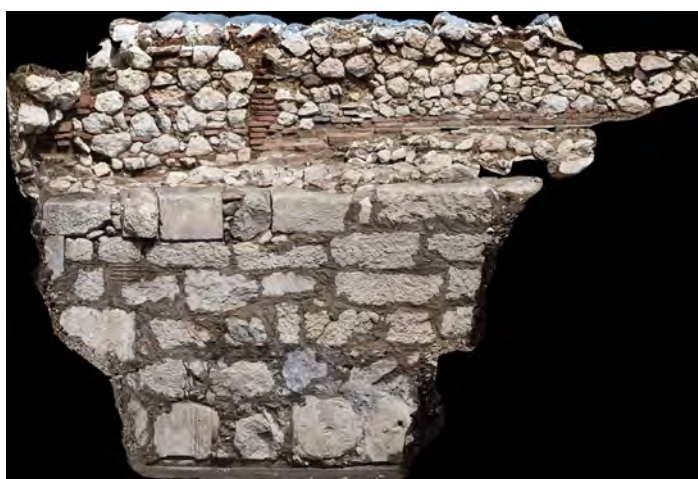
Fig. 47. Part of the 350-400 CE western wall of the late antique Agora Building, and the 275-325 CE support wall in front of it.

On top of the former division wall of the Agora-Gymnasium's ground floor, the new western wall of the late antique Agora Building was built in mortared rubble, reused ashlar and other *spolia* (Fig. 43 and 47). In front, a stepped structure in mortared rubble and *spolia* – including part of an Aphrodite statue – was set on the 275-325 CE support wall, which could have functioned as an elongated bench (Fig. 47). While there is no direct stratigraphic evidence, the western wall is abutted by various 350-400 CE structures, which together with the destruction of the Agora-Gymnasium, allows situating its construction around 350-400 CE. The division wall included at least three entrances, which facilitated access from the agora, possibly via a new portico, and a western forecourt, to the late antique Agora Building (Fig. 43). The largest of these entrances (2.30 m) led to Space 1 (Fig. 43) and consisted of a still *in situ* ashlar door threshold and posts with features indicative of a double-hinged door. The area leading up to it included a step, followed by repurposed limestone paves, which must have transitioned into a beaten earth or otherwise paved walking level which ran up to the agora (Fig. 48). In front of this entrance, two reused bases were positioned in alignment with the doorposts, and carried columns, creating an imposing entrance area which stood at least 3.15 m tall (Fig. 48). At the transition of the agora to the western forecourt, two honorific monuments stood in alignment with

Like its western counterpart, the former eastern aisle was backfilled during 350-400 CE. On top, an elongated structure connected to the arcade was built. The western extent was defined by the already discussed wall placed on top of the former division wall (Fig. 47),

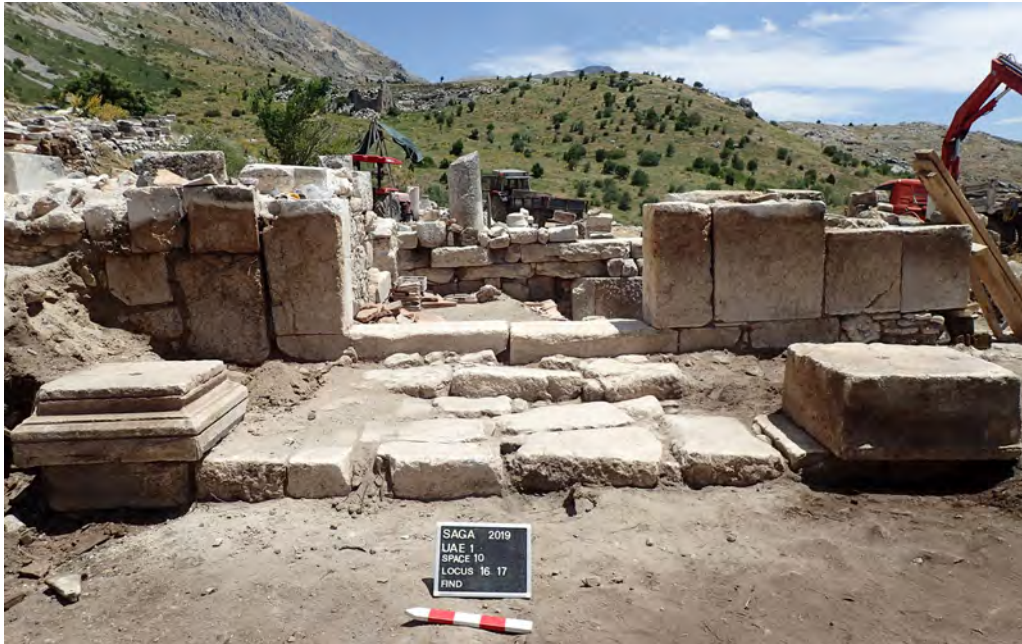
Fig. 48. Western view of the main western entrance to the late antique Agora Building.  
© Sagalassos Archaeological Research Project.

this main entrance.<sup>82</sup> Because of their similar dimensions and mode of production, these monuments were probably produced simultaneously. One was dedicated to Emperor Constantius II (337-361 CE) and could be epigraphically dated between 346-361 CE.<sup>83</sup> Initially, it was assumed that the second monument honoured the same emperor<sup>84</sup>, but recent analyses favour Emperor Constans (337-350 CE).<sup>85</sup> This suggests that these monuments were produced before news of the latter's death in 350 CE reached Sagalassos. As the late antique Agora Building did not yet exist then, these monuments originally stood somewhere else, and were moved at a later date. A smaller, second entrance (1.50 m) was situated approximately 7.6 m northwards and facilitated access to Space 3 (Fig. 43). Lastly, about 12.2 m northwards, a limestone threshold (1.61 m) evidences another entrance at the northernmost extremity of the division wall as it transitions into a series of piers. This entrance was located opposite the double rectangular recess in the western wall of the former bathing facility (*supra*) and provided access to Space 5 (Fig. 43).
