FROM HELLENISTIC NEIGHBOURHOOD TO BATH-GYMNASIUM AND  
BEYOND

The archaeology east of the Upper Agora of Sagalassos

BAS BEAUJEAN, JOHAN CLAEYS, DRIES DAEMS, FRANS DOPERÉ, PETER TALLOEN &  
JEROEN POBLOME\*

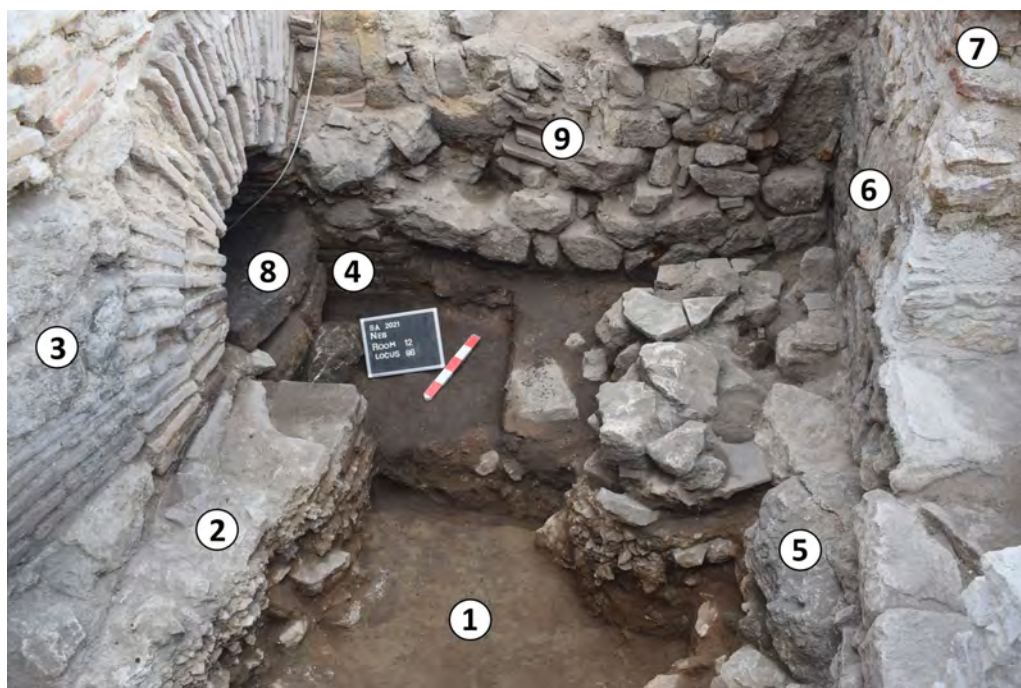
Fig. 49. Northern view of Room 12/13. Indicated are (1) the tephra, (2) the 75-125/200 CE foundations of the northern wing's western wall, (3) the western wall and vaulted service corridor, (4) the broken western extension of this corridor, (5) the mortared rubble foundations of the brick piers, (6) the mortared rubble and ashlar foundations of the brick piers, (7) a brick pier, (8) the 350-400 CE tuff rock blockage wall of the service corridor, (9) the 550/75-650/75 CE division wall of Room 9 and 10. © Sagalassos Archaeological Research Project.

southernmost one has collapsed westwards. The dating of these piers requires some elaboration. Their foundations consisted of a continuous stack of mortared rubble, which to the east was placed on the undisturbed tephra (Fig. 49), and to the west on either the mortared rubble or brick courses of the 75-125 CE division wall (Fig. 28). From an eastern perspective, the mortared rubble segment transitioned into mortared blocks (Fig. 49). This eastern face was abutted by 300/350-400 CE deposits of loose building debris (Fig. 40), providing a *terminus ante quem* for these foundations. A *terminus post quem* for the western face is provided by the 75-125 CE brick section, as the mortared rubble segment on top is abutted by 350-450 CE levelling fills, and the 350-400 CE northern wall of Room 7 (Fig. 28). The evidence allows us to conclude that the foundations were built between 75-125 CE and 350-400 CE. That at least the brick piers on top were built during 350-400 CE is established by the fact that the northernmost pier abuts the inner face of the 350/400-450 CE northern wall (Fig. 50). Furthermore, at its southern extremity this pier included a spring towards a W-E oriented series of makeshift piers with a *terminus post quem* of 350-400 CE (Fig. 50, *infra*). In addition, as discussed, a 350-400 CE trench – backfilled with building debris (Fig. 40) – cut through the foundation trench of

the 75-125/200 CE western wall of the bathing facilities. Beyond the piers, there is no structure that this trench can be associated with. This suggests that at least the eastern part of the foundations was modified. Third, the continuous mortared rubble foundations suggest that during their final arrangement there was no connection between the western and eastern aisle along the piers' trajectory. However, the stratigraphic differences between the layers immediately west of the hypocaust's service entrance, and its southern profile can only be explained by a now lost wall which once continued westwards. In all likelihood, this lost wall defined the westwards continuation of the service corridor, as suggested by its protruding part pointing westwards in the same profile (Fig. 49). To the north this

Room 9 and 10 were the result of the subdivision of Space 5 by a W-E oriented mortared rubble, brick and tuff rock wall ( $2.53 \times 0.20\text{--}0.26 \times 1.21\text{--}1.31$  m) installed on top of 550-650/75 CE levelling deposits (Fig. 49). Possibly at the same event, the doorway between Room 6 and Room 9 was filled in with rubble, brick and tuff rock (Fig. 50). Based on the discovery of sherds of glass on both sides, it might have been turned into a window. In all likelihood related to these changes, an opening was carved through part of the northernmost pier, linking Room 2 to Room 9. As there was no direct access between Room 9 and 10, this meant that Room 2 and 9, and Room 7 and 10 could have functioned as independent units, with Room 6 serving as a hallway (Fig. 59).

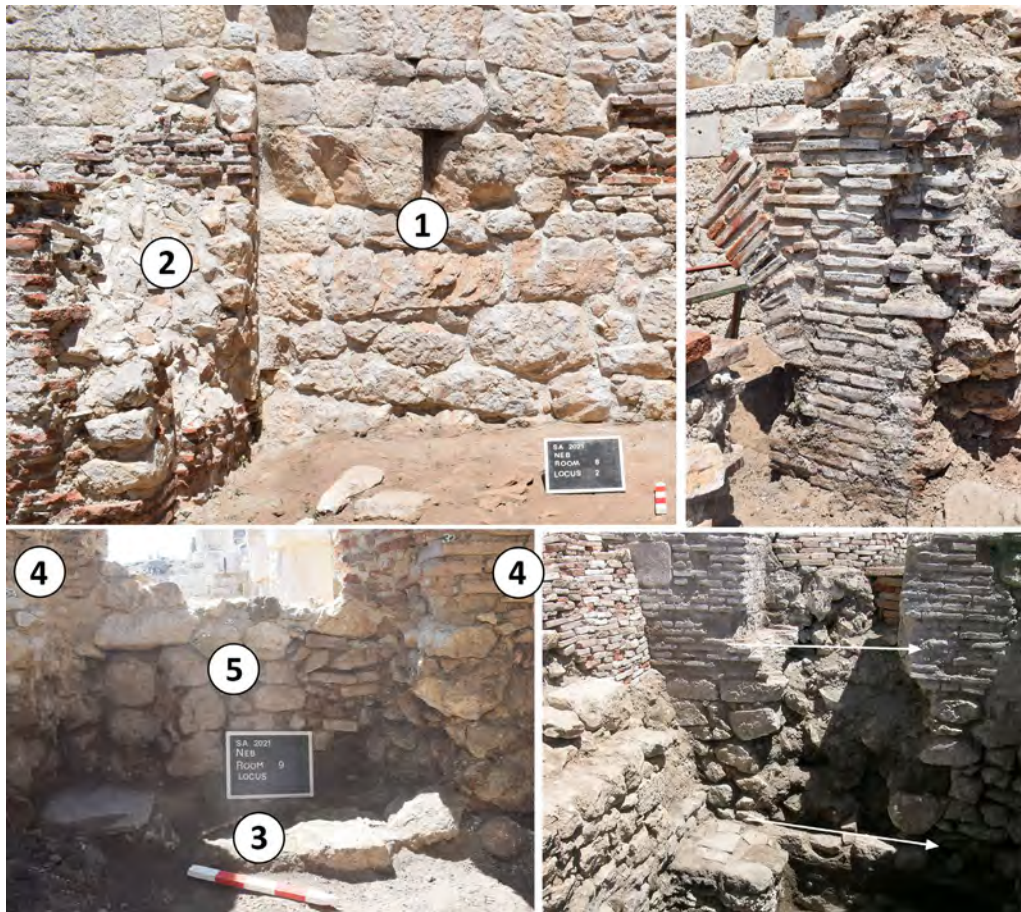
Fig. 50. (upper left) The (2) northernmost brick pier abuts (1) the 350/400-450 CE inner face of the northern wall. (upper right) The spring in the brick pier connecting to the WE oriented arcade. (lower left) Eastern view of the northernmost entrance in between two piers, including (3) the threshold, (4) the brick piers, and (5) a 550-650/75 CE blockage wall. (lower right) Western view of the southernmost entrance in between two piers, including the 350/400-450 CE threshold (upper arrow), and the 550-650/75 CE threshold aligning with the later floor (lower arrow).

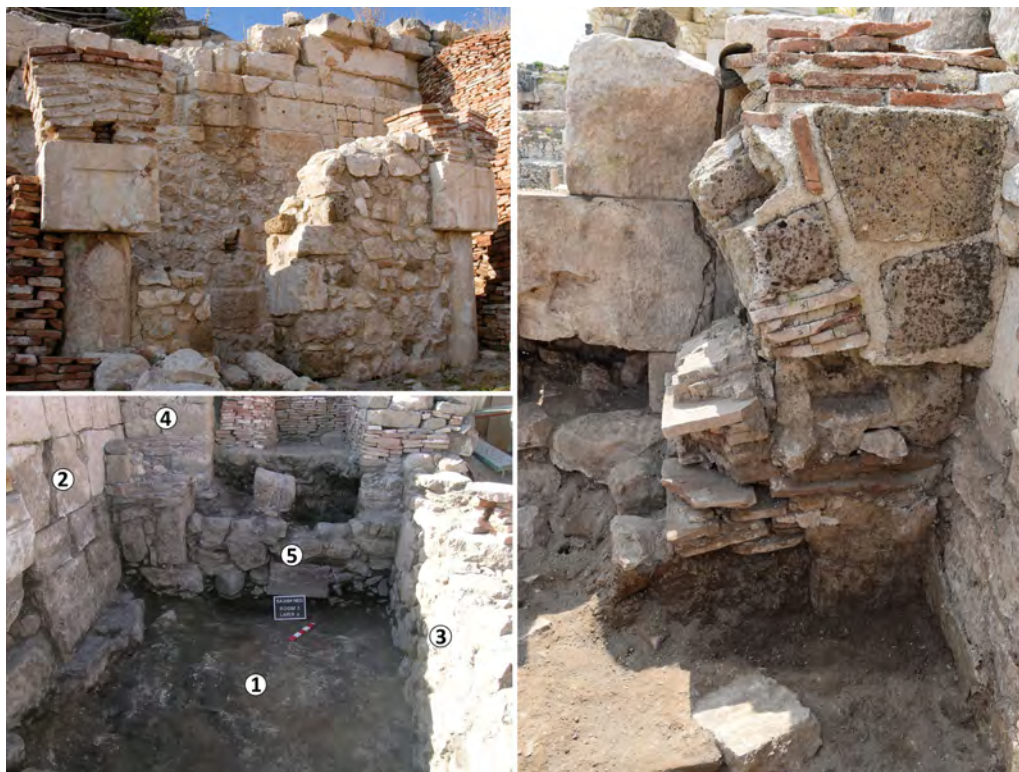
Fig. 51. (upper left) The 350/400-450 CE eastern and central supports of the WE oriented colonnade, and the 550-650/75 CE mortared rubble wall in between. (lower left) Southern view of Room 5. Indicated are (1) the mortar floor, (2) the northwestern wall of the late antique Agora Building, (3) the division wall subdividing Room 5 and 6, (4) the western support of the WE oriented colonnade, and (5) a later fill-in when the floor was raised. (right) The double vaulted structure in the NW corner of Room 1, which is linked to the WE oriented colonnade.

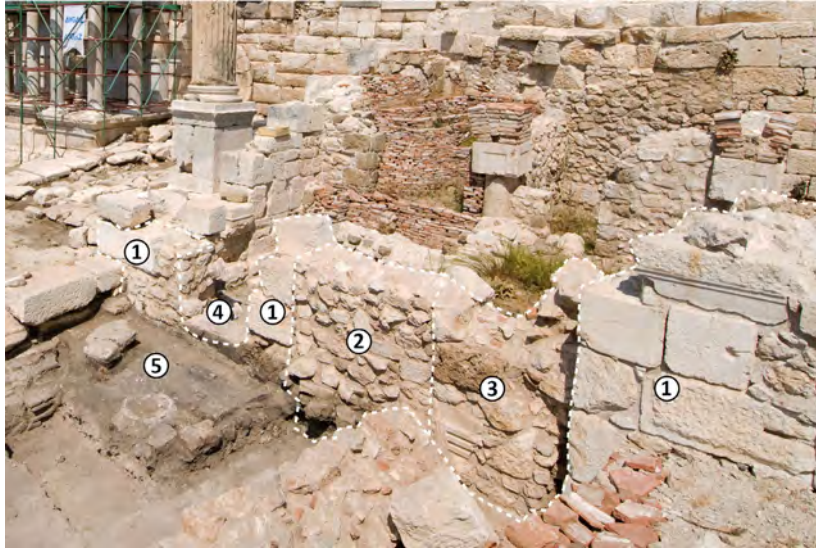
Fig. 52. Southeastern view of the southern wall. Indicated are (1) the remaining segments of the 350/400-450 CE southern wall, (2) the 350/400-450 CE entrance to Room 5/6 and 550-650/75 CE fill-in, (3) the 350/400-450 CE entrance to Room 7 and 550-650/75 CE fill-in, (4) the 550-650/75 CE entrance to Room 5 and 1 (independent unit), and (5) the associated walking level with part of a storage pot.

during 350-400 CE considering the abutting deposits (Fig. 43). The southern wall of Room 7 was part of a W-E oriented wall, which included the original central entrance (2.75 m) to Room 5/6, as well as the arcade beyond (Fig. 52). The outer face indicates that the entrance was narrowed twice. However, the presence of the 350-400 CE western wall of Room 7 abutting the inner face exactly between these fillings suggests we are dealing with separate entrances to Room 5/6 and 7 respectively (Fig. 52).

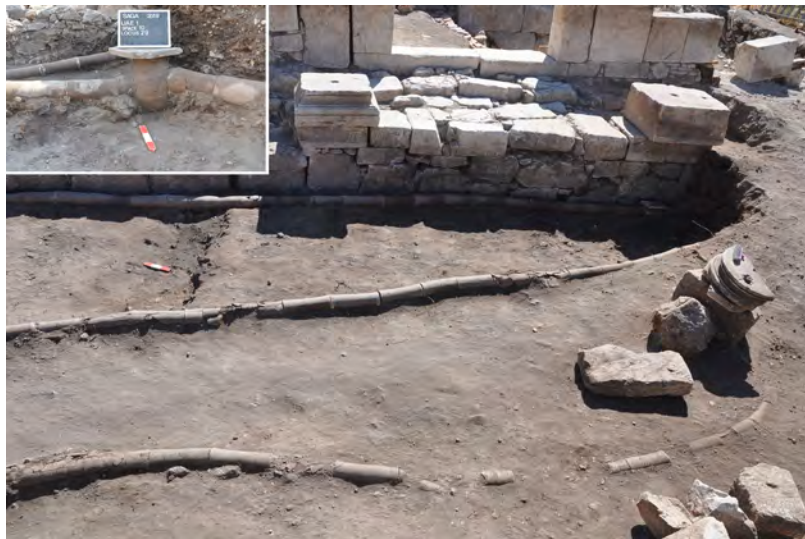
Fig. 53. The three easternmost water pipes descending southwards along the western main entrance of the late antique Agora Building. (upper left) The connecting basin linked to the westernmost pipeline.

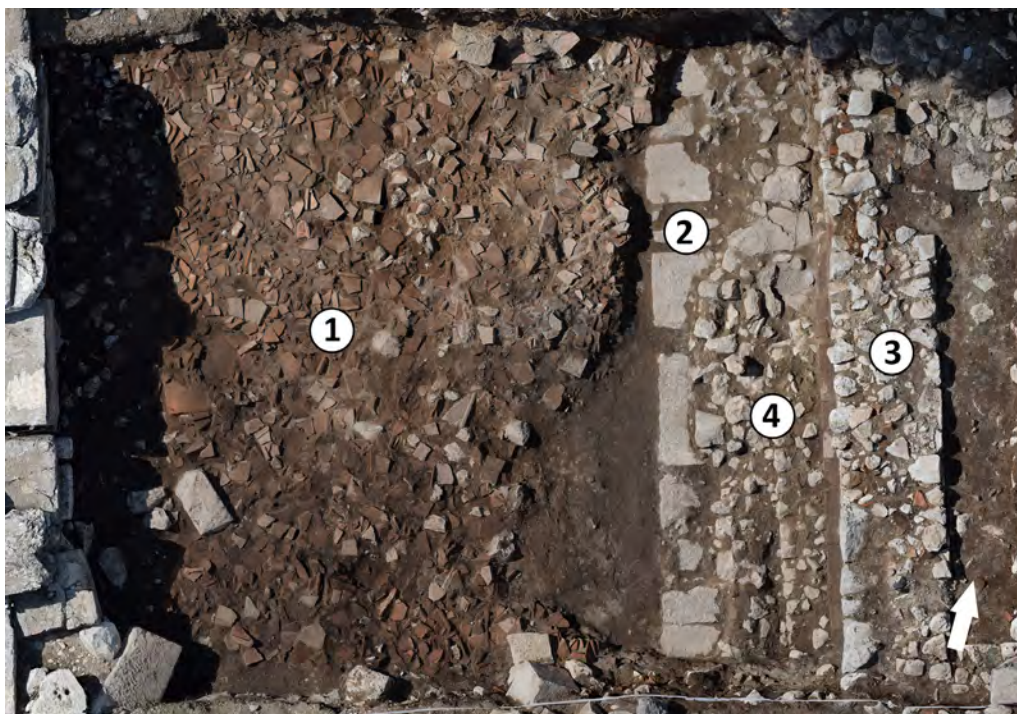
Fig. 54. Orthophotographic image of (1) the 375-425 CE accumulation of building debris near (2) the (former) 275-325 CE support wall, (3) the western wall of the late antique Agora Building, and (4) the bench-like structure in front of it. © *Sagalassos Archaeological Research Project*.

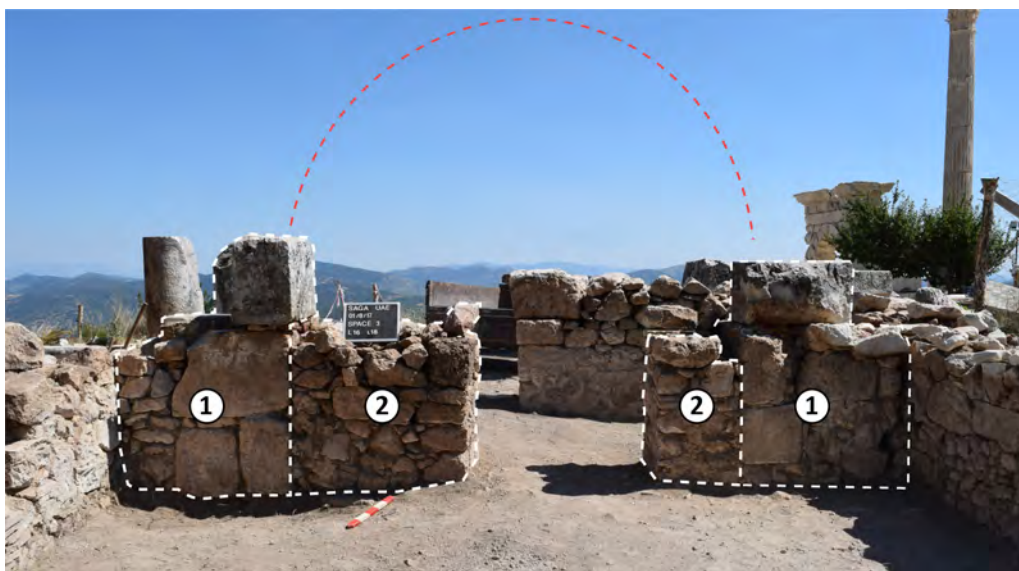
Fig. 55. (1) The 350/400-450 CE entrance between Space 1/2 and 3, and (2) the later segments narrowing its width. In the background, the (likely) later division wall between Space 1 and 2 is visible.

The entrance between Room 2 and 3 was narrowed by extending the wall segments with mortared rubble (Fig. 55). Considering the nature of these fill-ins, this is unlikely to be related to problems with structural integrity, but rather seems to define Room 2 and 3 more as independent units. Furthermore, the western entrance of Room 3 was filled in, which created a shallow niche (Fig. 56,  $1.6 \times 0.6$  m), and leaves the main entrance as the only known option to enter the central building from the west. This fill-in consisted

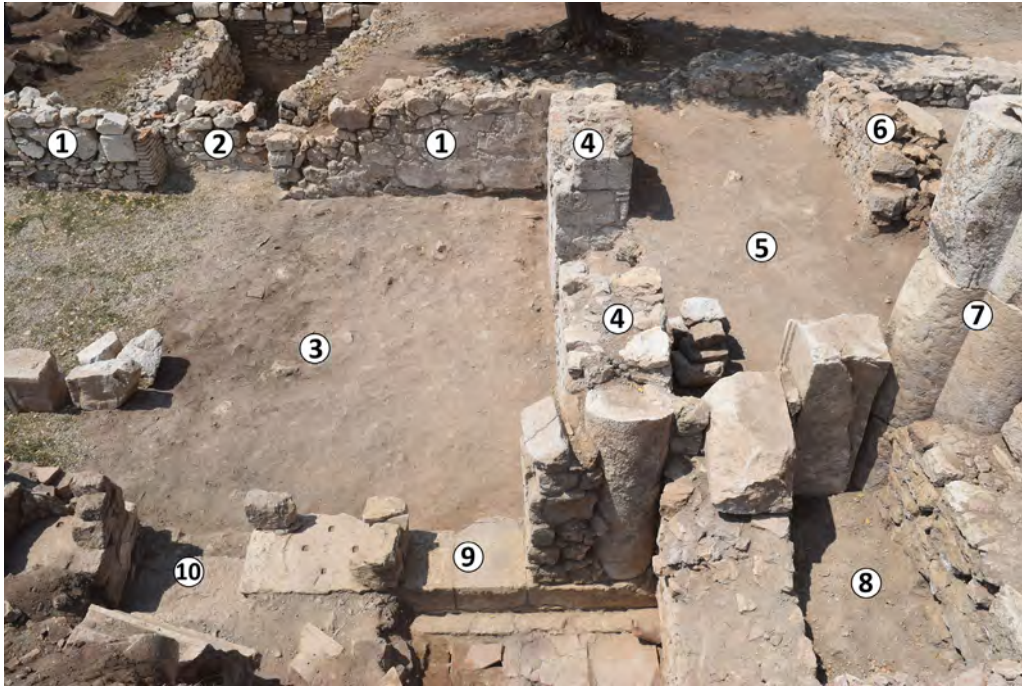
Fig. 56. Eastern view upon the central part of the late antique Agora Building. Indicated are (1) the western wall, including (2) an entrance which was filled in at a later date. (3) Space 3, and (4) its northern wall providing access to (5) Space 4. (6) The northern wall of the latter is poorly preserved, and its eastern wall incorporated the NW heart-shaped column of the palaistra's portico. To its east, (8) Space A2 is situated. Finally, in the western wall – which incorporated the western portico – a (9) doorway and (10) window were present. © *Sagalassos Archaeological Research Project*.

At some point, small walls (c.  $1.5 \times 0.75 \times 1$  m) were built between the columns of the western portico, which had already been integrated in W-E oriented division walls. It is thus possible that this occurred shortly after the central building had been built. This created a continuous wall consisting of mortared rubble, brick, tuff rock, and *spolia* set between the columns (Fig. 8). While the western portico remained standing, the northern portico was dismantled up to its stylobate, on top of which a wall made of mortared rubble, brick, and *spolia* was installed. Amongst the *spolia* was the aforementioned wall frieze block depicting Ajax the Lesser and Cassandra (Fig. 32). As it was placed upright at eye level, at least its aesthetic qualities could still be valued. Immediately south, a smaller mortared rubble wall was constructed in parallel, creating a channel-like structure (0.65 m). The area in between makes up Space A2 (Fig. 4). In Space 3, a section between two columns was left open, and based on the height of a tuff rock arch functioned as a window. Immediately north, part of the stylobate was removed to create a door opening eastwards (Fig. 56).

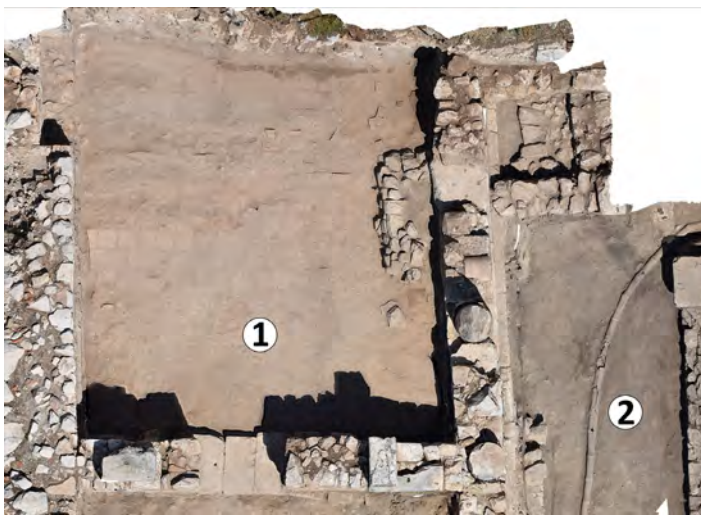
Fig. 57. The 350/400-450 CE brick floor of (1) Space 3, and the final phase of use of (2) the passageway. © *Sagalassos Archaeological Research Project*.

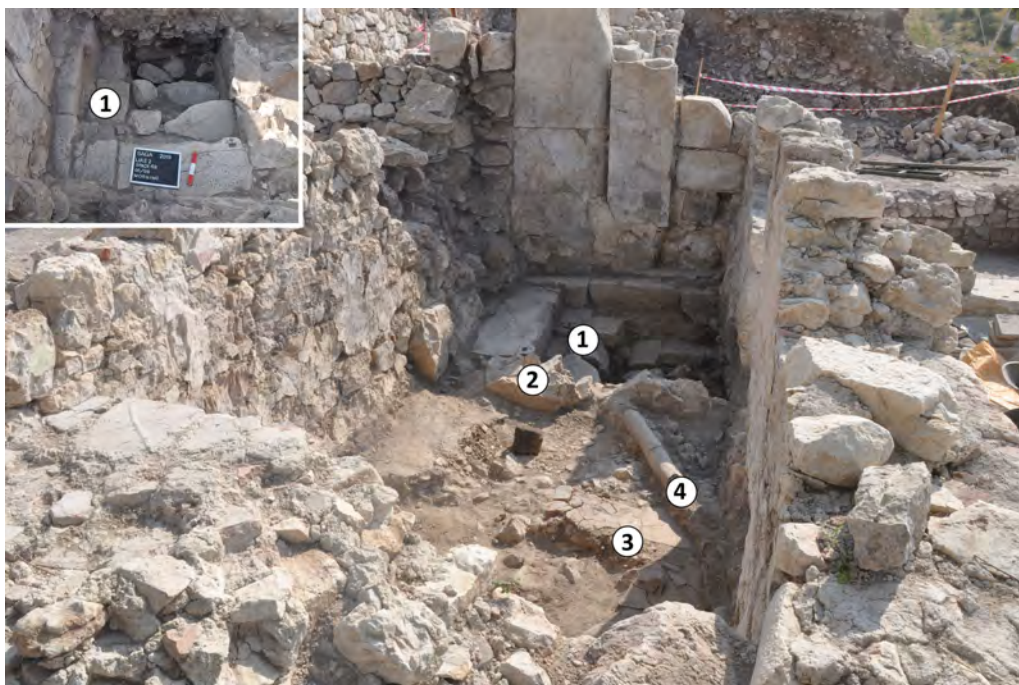
Fig. 58. Western view of Space 4. Indicated are (1) the staircase and associated limestone paves, (2) the 550-650/675 CE division wall, (3) the 550-650/675 CE brick floor, and (4) the 550-650/675 CE water pipe. © Sagalassos Archaeological Research Project.

late antique Agora Building, and incorporated the NW heart-shaped column in its eastern wall, while its northern wall was mostly constructed in mortared rubble and *spolia* (Fig. 58). Possibly, it was built at a later date, and there was originally a connection between Room 3 and Space 5. In the eastern half of Space 4, a stairway was situated, and was composed of large limestone slabs, as well as *spolia*, and brick fragments (Fig. 58). Considering the fact that the stairway was set in the 350-400 CE deposits, and the northern and southern wall of Space 4 were installed on top of it, it was part of, and possibly preceded the construction of the late antique Agora Building. The steps descend towards the south, suggesting that part of the former ground floor was reused as a basement.

A small N-S oriented rubble wall subdivided Space 4 into a western (4a) and eastern (4b) half (Fig. 58). This subdivision was reverted later on as the division wall was dismantled to facilitate the arrangement of a floor set in brick and tile fragments (Fig. 58). On top, a hearth delineated by rubble was located in the eastern part of the room, and could be linked to an associated *in situ* cooking vessel. The layer on top contained material dating to 500-600/650 CE, providing a *terminus ante quem* for all of these activities.

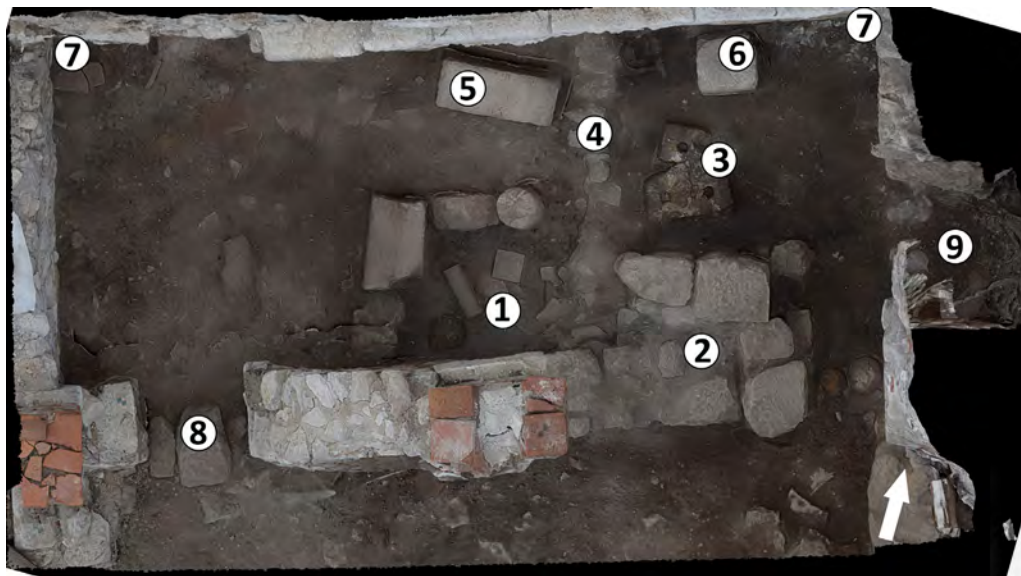
Fig. 60. Orthophotographic image of 550-650/75 CE NEB Room 2. Indicated are (1) the basin used for mortar production, (2) the U-shaped structure, (3) the tuff rock feature, (4) the rubble threshold, (5) the limestone bench and (6) seat, (7) the NW and NE slaked lime deposits, the entrance to (8) Room 6 and (9) Room 9.

feature with three postholes ( $0.56 \times 0.56$  m). Considering the heat retention of tuff rock, the latter served to fixate something to be heated. Furthermore, we find a brick disc repurposed as a support for something, a vertically placed terracotta water pipe immediately south of a slaked lime concentration, and a U-shaped structure ( $0.95 \times 1.05$  m) partially stabilized by a reused lid (Fig. 60). For the western segment, another concentration of slaked lime was situated in the NW corner, while a large limestone block was reused as a bench along the northern wall, and a rectangular basin ( $1.3 \times 1.25$  m) was used for lime-based mortar production (Fig. 60). As such, the final use of Room 2 indicates activities in part associated with mortar production (e.g. repairs, plastering). To the east, a stairway of limestone blocks descended to Room 9 (Fig. 61). In its final phase, at least seven storage pots were situated along the western, eastern and southern wall, and various other ceramic objects – like a water jug and plates – stood on shelves. The associated floor level mostly consisted of beaten earth, but also included three limestone paves, as well as part of the mortared rubble foundations of the former bathing facilities (Fig. 61). The floor substrate could be dated to 550-650/75 CE. In addition, a NW-SE oriented structure ( $2.06 \times 0.28$ - $0.37 \times 1.27$ - $1.32$  m) was built against the stairway and the northern wall, and consisted of reused ashlar, bricks and tuff rock (Fig. 62). The central part was situated more westwards, creating a small platform or alcove, which presented soot marks, charcoal fragments, and

In the northern area, a variety of dumping activities have been attested. In NEB Room 2, the rectangular basin (Fig. 60) was used to dump misfired ceramics, eggshell, seashells, and lentils. Outside of the basin, a variety of metal objects (e.g. knives, a ring) and other refuse was deposited. Based on the ceramics, this occurred during 625-675 CE. Likely after the dumping activities, the doorway to Room 2 was filled-in with limestone rubble. In NEB Room 5, refuse including pottery, a variety of metal objects (e.g. knives, keys), and bone hairpins was deposited. The collapse on top can be dated to 550-650/75 CE. While NEB Room 1 was not excavated up to a walking level, it could only be reached via Room 5, making it likely was abandoned as well. Similarly in Room 6, a refuse heap was situated against the western wall, and included lots of pottery, faunal remains, and some other objects (e.g. oil lamps, horse figurine, flasks). The ceramics could again be dated to 550-650/75 CE. Archaeozoological analyses suggest that most faunal remains concerned domestic consumption. However, the bones in the dump presented a dominance of ovicaprines possibly indicative of a nearby butchery. In close proximity to the 550-650/700 CE walking level of Room 9, large amounts of cow and goat horns, as well as some deer's antlers were found. These dumps seemed to be linked to bone-working activities. In addition, a small bell for animals, various knives, and a metal object likely used to process cattle were amongst the refuse. A final modification in the northern area was the filling in of the central entrance with rubble (Fig. 52). This is associated with the construction of a cistern in front of it. This N-S oriented structure was composed of a mortared rubble wall (2.53 × 0.86 m), a pier (1.27 m), and was covered by a barrel vault (Fig. 52). Taken together, dumping activities across all northern rooms, and the filling-in of entrances indicate the gradual abandonment of the northern area during 550-650/75 CE. This also explains why macro-botanical analyses of the 550-650/700 CE *in situ* storage pots provided little result, as most of the contents of the room were probably taken along when they were abandoned. The increasing evidence of crude repairs and construction activities suggests that structural instability was one of, if not the main, reason for this abandonment. A general lack of maintenance for the surrounding area is also indicated by Northeast Street being gradually covered by a dark brown to blackish layer of silt. However, the construction of the cistern does suggest that the area was not entirely abandoned. To the south, the partial collapse of the western wall of the late antique Agora Building might also have begun before a mid-7<sup>th</sup> c. CE earthquake hit Sagalassos. This is indicated by loose debris in small 575-625 CE collapse layers west of it, below the larger 550-650/75 CE collapse. The only activities which have been documented in the forecourt include the positioning of various larger blocks along the border of the agora.

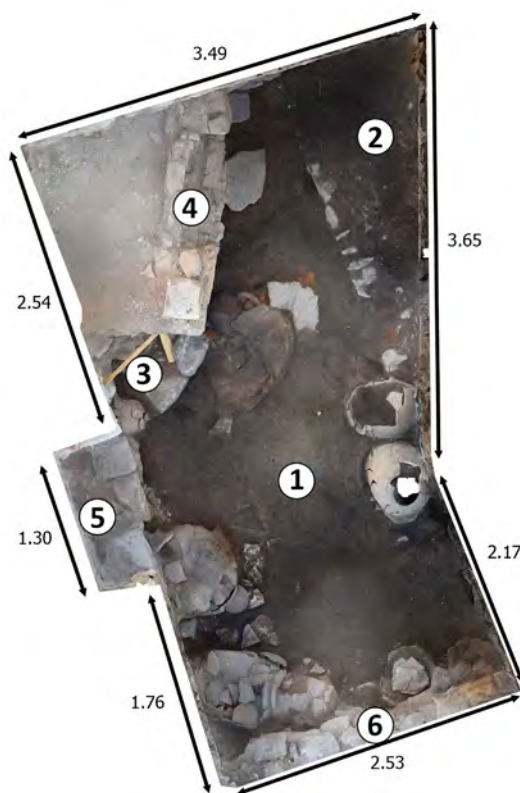
Fig. 61. Orthophotographic image of 550-650/75 CE NEB Room 9. Indicated are (1) the 550-650/75 CE beaten earth walking level and storage pots, which included (2) the foundations of the 75-125/200 CE northern wing, (3) the stairway ascending to Room 2, (4) the tuff rock feature (see fig.62), (5) the 350/400-450 CE doorway (a likely 550-650/75 CE window), and (6) the 550-650/75 CE division wall with Room 10.

some vitrified faunal remains. The function of this feature remains undetermined. Based on beam holes in the piers and opposing wall, as well as the presence of another storage pot on top of the western wall (Fig. 61), we can argue that multiple floors remained in use into 550-650/75 CE. In its final phase Room 9 was in part a storage room, but also facilitated other activities. Considering Room 2 and 9 together, we are possibly dealing with a domestic unit. Finally, as mentioned above, a storage pot was present upon the final walking level of Room 7, suggesting a function as a partial storage room.

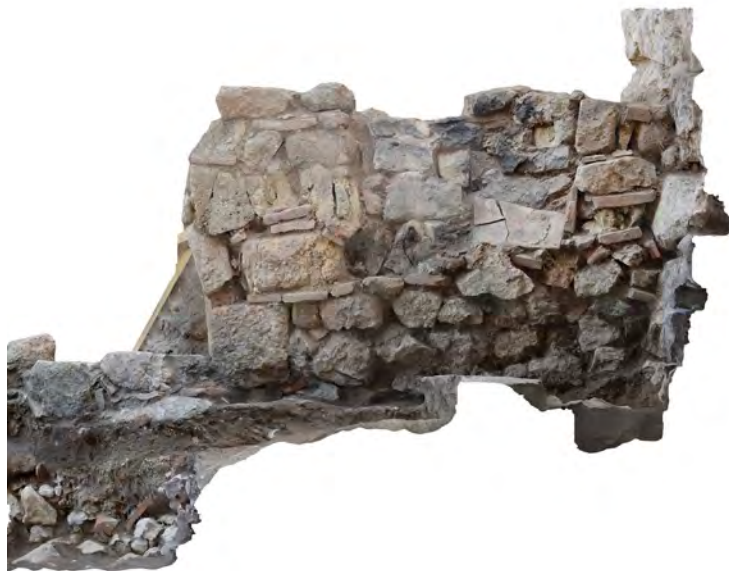
Fig. 62. The tuff rock, rubble and spolia feature in the NW part of Room 9 (see fig.61). Note the soot marks in the central platform. © *Sagalassos Archaeological Research Project*.

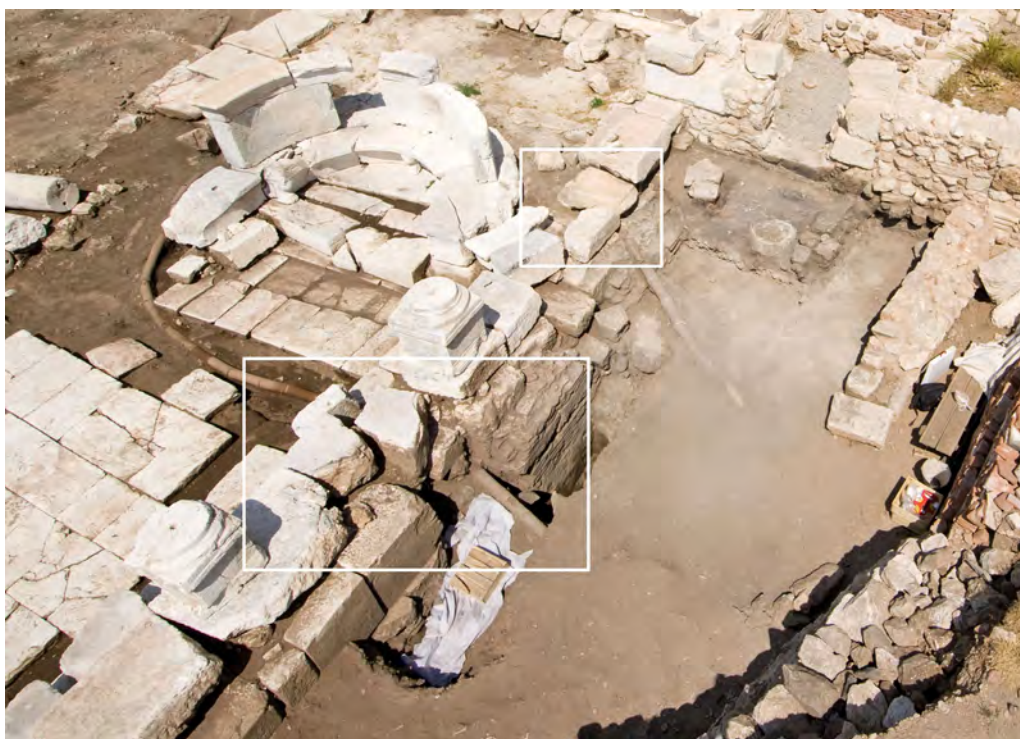
Fig. 63. The 550-650/75 CE water pipes installed in between the border stones. In addition, the pedestals of the 550-650/75 CE colonnade on top can be observed.

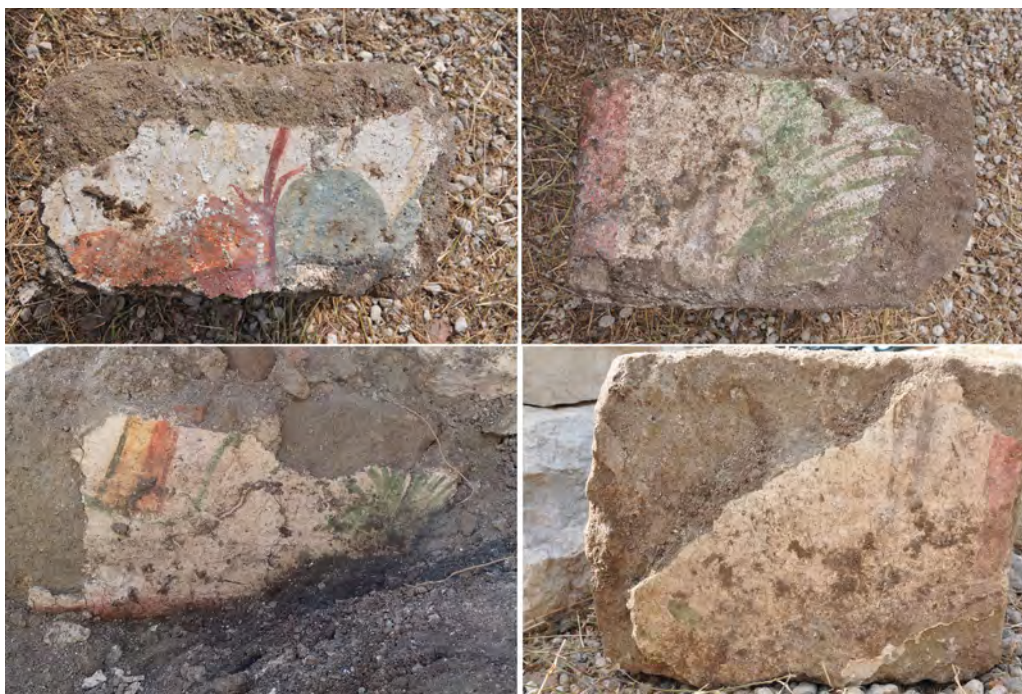
Fig. 64. Several examples of the painted plaster belonging to multiple phases of the late antique Agora Building and its later subdivision.

During 550-650/75 CE, the late antique Agora Building was increasingly subdivided in more independent units, while connectivity between rooms decreased (Fig. 59). In addition, we have evidence throughout the building for storage rooms, often linked to a single other room. Furthermore, even when taking into account that later phases leave more evidence than earlier ones, it is striking that the intensity of modifications increases. This is more characteristic for domestic than public spaces. Taken together, we argue that the late antique Agora Building lost its civic function, and was subdivided in a series of domestic units, including latrines and associated sewage. In a sense, it became a neighbourhood once more. Both for the late antique Agora Building and the later domestic units, the interior was more aesthetically pleasing than its preservation implies, as painted plaster has been found throughout the area. The presence of painted plaster in earlier and later phases of Room 1/2 and 2 consisted of an older red panel, which had been painted over with a brighter red, yellow and blue (Fig. 64). In contrast, only plain white plaster remained on the western and southern wall. In Space 3, the small walls between the columns were plastered as well, and decorated with red bands as well as some yellow/black/green floral motifs (Fig. 64). Space 4A was damaged by the vault's collapse, and seemed to have been decorated with painted plaster present on at least some of the tuff rock blocks. In addition to floral motifs, a figure can be observed (Fig. 64).

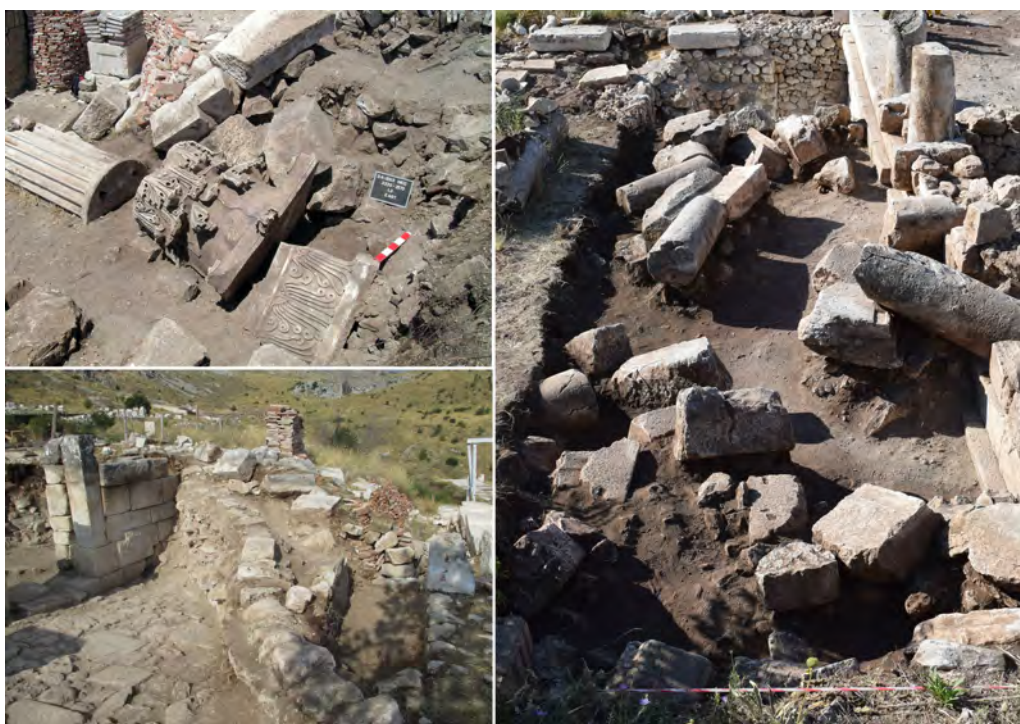
Fig. 65. (upper left) The collapsed NE honorific column. (right) The collapse of the western portico into the passageway. (lower left) The Byzantine water channel constructed on top of collapse layers, emerging from the southern wall of the former Agora-Gymnasium and crossing Southeast Street.

The abandonment and declining maintenance facilitated the destruction by a mid-7<sup>th</sup> c. CE earthquake. The NE honorific column – constructed in 25 BCE-25 CE – toppled eastwards, its column drums and capital were sent crashing down through the central part of the northern area (Fig. 65). Along the northern and western wall, the 4 m-thick collapse layers included lots of bricks, tiles and mortar fragments, as well as countless nails representing the destruction of multiple floors and a tile roof. The eastern wall of the central building – including the western portico – collapsed eastwards as well, in part destroying the likely abandoned Space A1a. In the collapse layers covering the former passageway, most of the column drums and entablature could be documented (Fig. 65), indicating that it stood up to the very end. Similarly, parts of the southern portico collapsed northwards, suggesting that at least part of this colonnade remained standing. In all likelihood, it is the same seismic event which caused the central vaults to collapse in the northern wing, bringing down columns as well (Fig. 29). While the earthquake did not cause the abandonment of the area east of the agora, after c. 800-950 years of a colourful range of activities, it was the final nail in the coffin for human occupation and use. The next attested activity concerns the construction of a large 650-700 CE water channel, which was laid out across the

upper and lower city of Sagalassos, crossing various parts of the former Agora-Gymnasium (Fig. 65). This water channel descended towards the new centre of the town, situated at the former location of the Temple of Antoninus Pius (Fig. 1).
